TECHNICAL BULLETIN # 230A

TRANSMISSION: E4OD

SUBJECT:

No upshift 4th [gear](#) starts, harsh upshifts, neutrals out after shifts

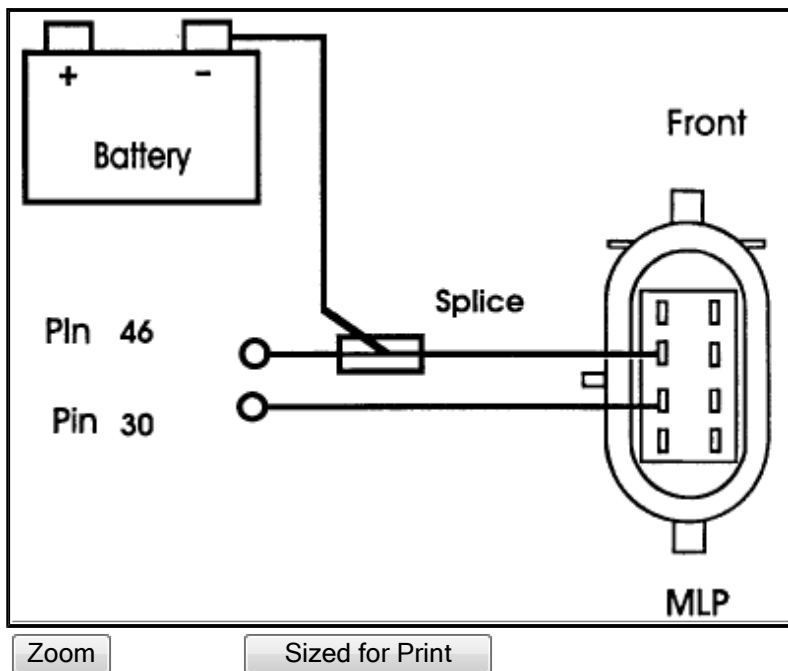
Check the MLPS ground: Turn the ignition on. The voltage on pin 46 (sensor

ground) should not exceed .1v. If the voltage is excessive, add an additional ground to the existing ground wire (figure 2).

Figure 2 Splice an additional ground from the existing ground wire to a known good ground. The negative post of the battery is the best. This view is of the pins of the MLP connector pins.

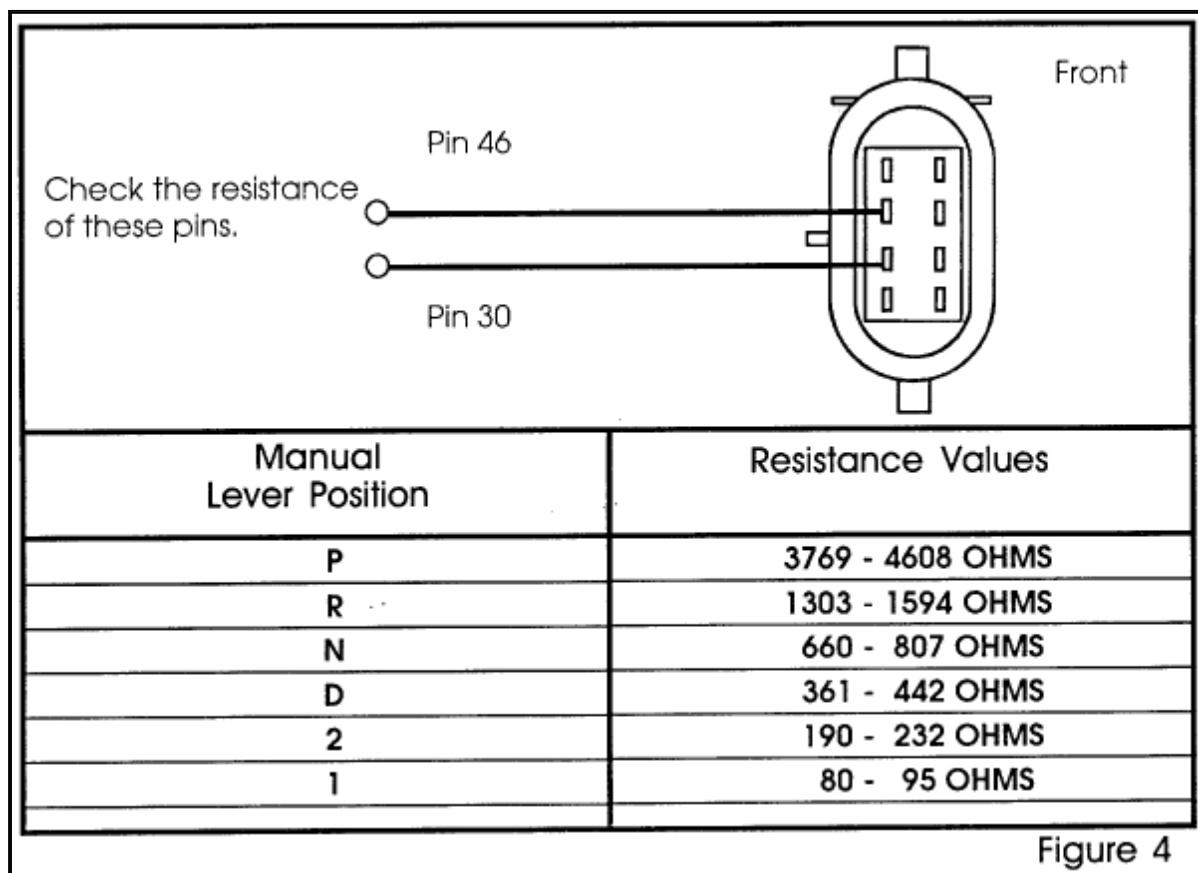
Check the resistance of the MLPS: The resistance of the MLPS (pins 30 and 46) should change-in increments-with the position of the manual lever (figure 4).
