Engine - Spark Knock on Light Load/Acceleration

TSB 07-16-17

SPARK KNOCK UNDER LIGHT LOAD AND
ACCELERATION - 3.8L, 3.9L, AND 4.2L - SPLIT PORT
INTAKE MANIFOLD RUNNER CONTROL (IMRC)

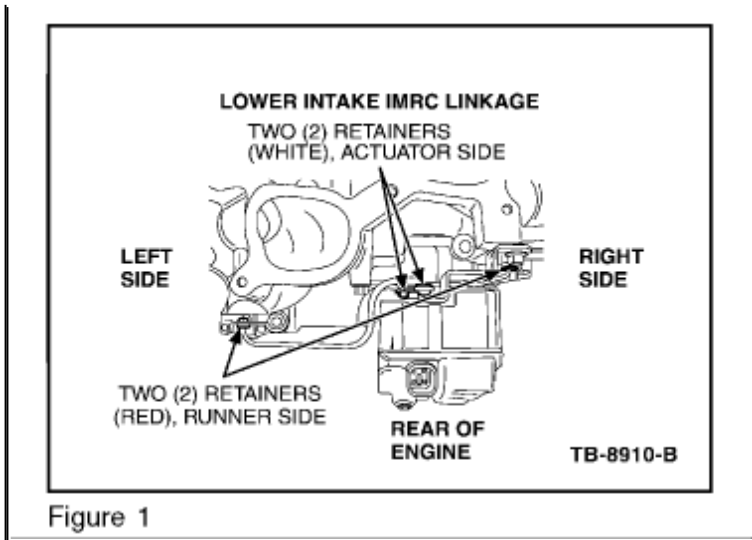
Inspect for disconnected IMRC actuator rods.

1. Check both right hand and left hand side IMRC rods are properly attached to the actuator motor and intake manifold runner.
2. If the IMRC actuator rods are found to be connected properly, do not continue with this TSB. Refer to Powertrain Control/Emission Diagnosis Manual.
3. If any IMRC actuator rods are disconnected, refer to Workshop Manual (WSM), Section 303-14 for IMRC service.

4. If any IMRC actuator rod linkages are found disconnected, replace all four (4) linkage rod retainers. (Figure 1
