## Suspension - Air Suspension Height Sensor Linkage Loose

TSB 06-15-10

### AIR SUSPENSION PERFORMANCE - HEIGHT SENSOR LINKAGE ARM DISENGAGING

FORD:  
2003-2006 Expedition

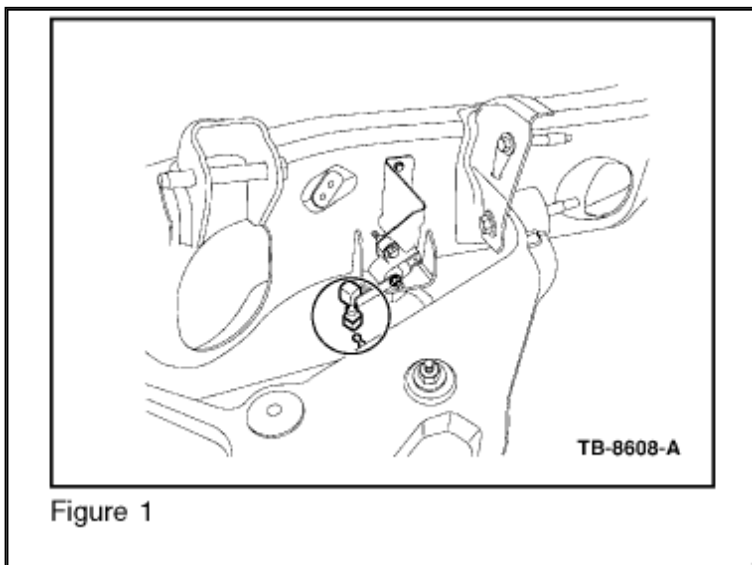
Some 2003-2006 Expedition and Navigator vehicles equipped with an air suspension may exhibit an air suspension height sensor linkage arm disengaging from the suspension ball stud or height sensor rotating arm. This concern typically occurs with the rear sensor (Figure 1) but may occur with the front sensors as well. If this occurs, the symptom will typically be the vehicle leaning to one side, the vehicle sitting too low/high, a harsh ride, and/or an inoperative air suspension. In addition, this concern may result in diagnostic trouble code (DTC) C1725 (air suspension front pneumatic failure) or C1726 (air suspension rear pneumatic failure).

When a linkage arm becomes disengaged, do not re-attach the arm and do not replace the sensor unless broken. Instead, install a revised linkage arm on all three (3) sensor assemblies, even if they have not detached from the ball stud.

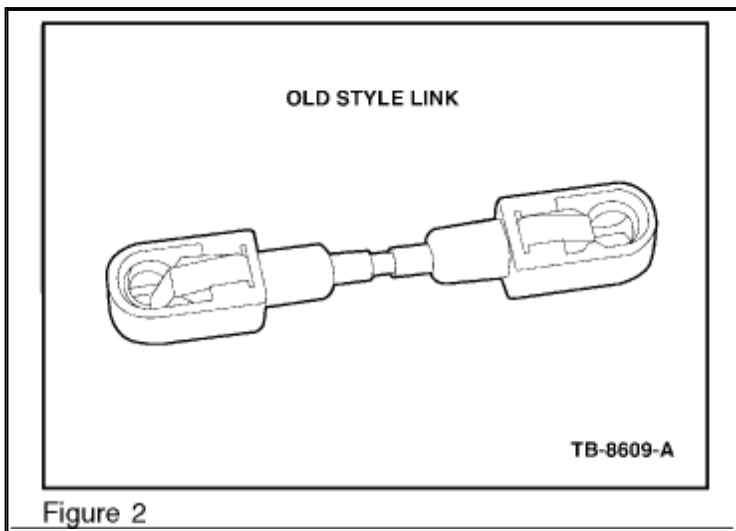
**NOTE** LINKAGE ARMS USED AS ORIGINAL EQUIPMENT ARE SHOWN IN FIGURE 2. REVISED LINKAGE ARMS (FIGURE 3) HAVE A NEW DESIGN THAT MAKES IT MORE DIFFICULT TO DISENGAGE FROM THE BALL STUDS.
