**FORD:**

2000-2005 Focus

This article supersedes TSB **02-25-1** to update the vehicle model years and service procedure.

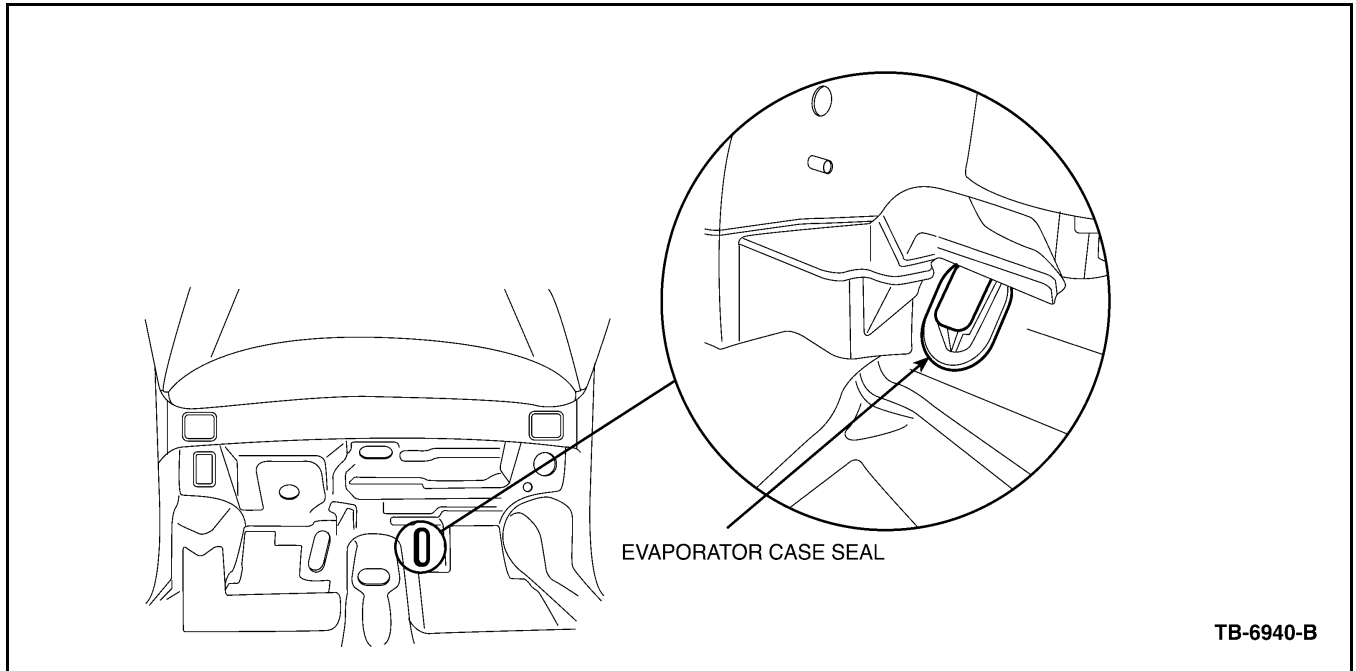
Figure 4 - Article 05-13-3

**Water is Visible on Evaporator Case Seal at the Heater Core Inlet/Outlet:**

1. Inspect for a mis-positioned evaporator case seal at the heater core inlet/outlet. Repair as necessary (Figure 4).

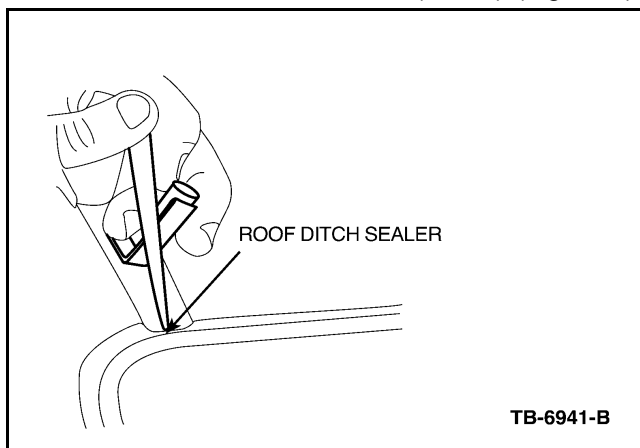
Figure 5 - Article 05-13-3

**Water is Visible in the Right Kick Panel/A-Post Area**

1. Inspect for sealer skip behind roof ditch moldings. Fold the ditch molding back and inspect for a pinhole in the body seal just above the windshield. Reseal as necessary with Motorcraft Roof Ditch Sealer (TA-15) (Figure 5).
