Wind Noise From Moon Roof

Service Category Vehicle Exterior

Section Sliding Roof/Convertible

YEAR(S)	MODEL(S)	ADDITIONAL INFORMATION
2005 – 2008	tC

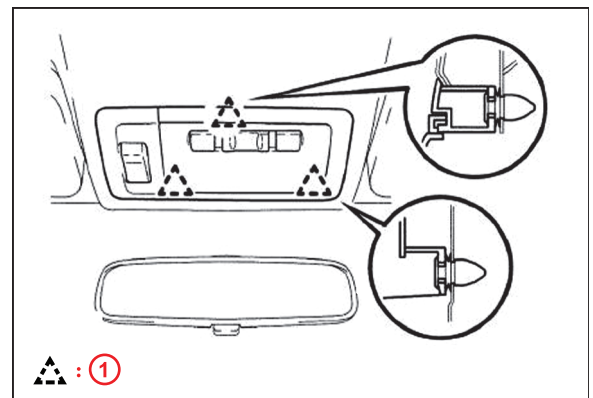
Figure 1.

2. Remove the map light assembly.
 - A. Using a clip remover, detach the 3 clips and remove the light.

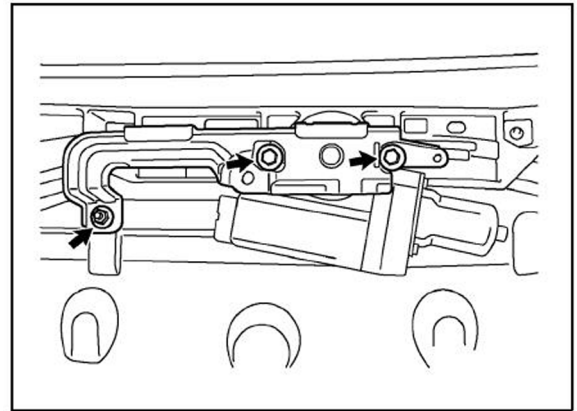
Figure 2.

- B. Disconnect the map light connector.
3. Remove the 2 bolts, nut, and bracket from the drive gear.

4. Remove the sliding roof drive gear assembly.
5. Replace the sliding roof drive gear assembly with the NEW service part (P/N 63260-21051).
6. Reinstall the 2 bolts, nut, and bracket to the drive gear.
