M.I.L "ON" DTC P2195, P2197, P0138, P0158, P0171, P0174, P0031, or P0051

Service Category Engine/Hybrid System

Section Engine Control

YEAR(S)	MODEL(S)	ADDITIONAL INFORMATION
2005 – 2007	Avalon	
2007 – 2008	Camry

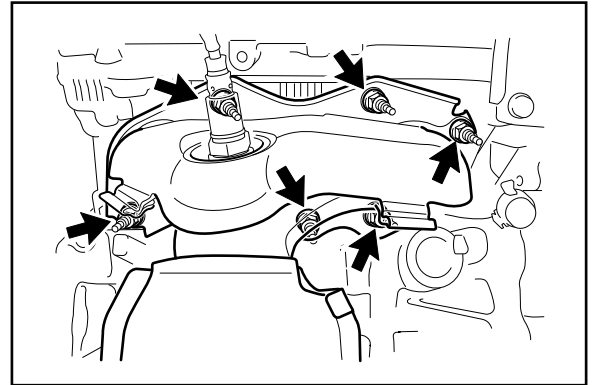
- (2) Uniformly loosen and remove the 6 nuts. **Figure 1.**

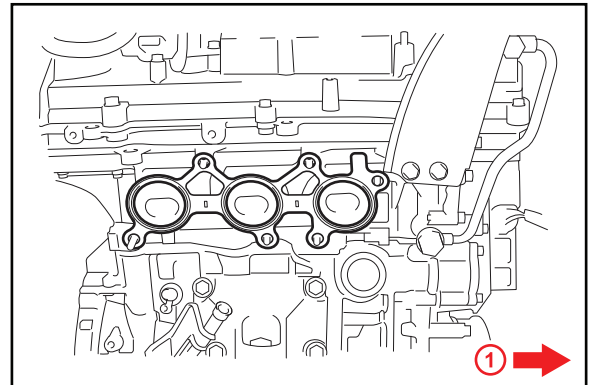
Figure 2.

- (3) Remove the manifold and gasket.
- (4) Install a NEW gasket as shown.

1	Front of Vehicle
----------	-------------------------

- (5) Install the NEW exhaust manifold sub-assembly RH with the 6 nuts and reassemble in reverse order.
Torque: 21 N*m (214 kgf*cm, 15 ft*lbf)
