TECHNICAL SERVICE BULLETIN

SUBJECT:		REAR CONTROL ARM SQUEAK		No:	TSB-05-34-001
				DATE:	July, 2005
				MODEL:	See below
CIRCULATE TO:	<input type="checkbox"/> GENERAL MANAGER	<input checked="" type="checkbox"/> PARTS MANAGER	<input checked="" type="checkbox"/> TECHNICIAN		
<input checked="" type="checkbox"/> SERVICE ADVISOR	<input checked="" type="checkbox"/> SERVICE MANAGER	<input checked="" type="checkbox"/> WARRANTY PROCESSOR	<input type="checkbox"/> SALES MANAGER

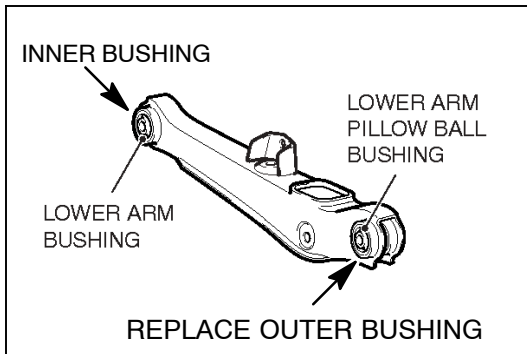
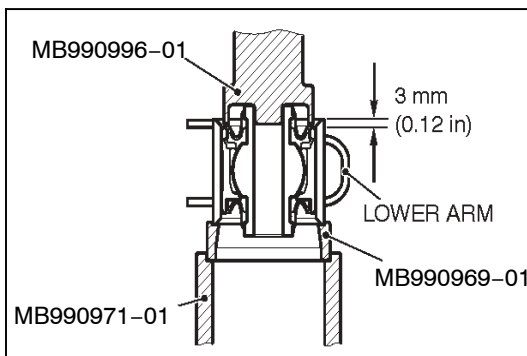
a. Lower Arm Bushing (Outer Pillow Ball Bushing)
Replacement Procedure:

This bulletin addresses customer complaints of a squeaking noise coming from the rear of the vehicle while driving. Water intrusion through the control arm bushing seal may allow corrosion, resulting in a squeak during control arm movement. The new replacement parts listed in this bulletin have improved bushing seals to prevent water intrusion.

Use special tools MB990969-01, MB990971-01, and MB990996-01 to drive out and press-fit the bushing. After press-fitting, the space between the edges of the bushing outer sleeve and the lower arm should be 3 mm (0.12 inch).
