HONDA ServiceNews

ASN 22447-40074 (0808)

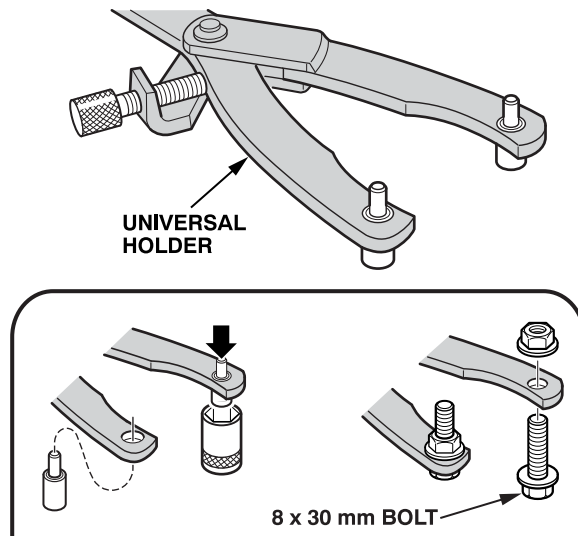
The original pins on the Universal Holder (T/N 07725-0030000) are too short to completely engage the holes in a power steering pump pulley. To improve this tool, press out the original pins, and install an 8 x 30 mm bolt into each hole.

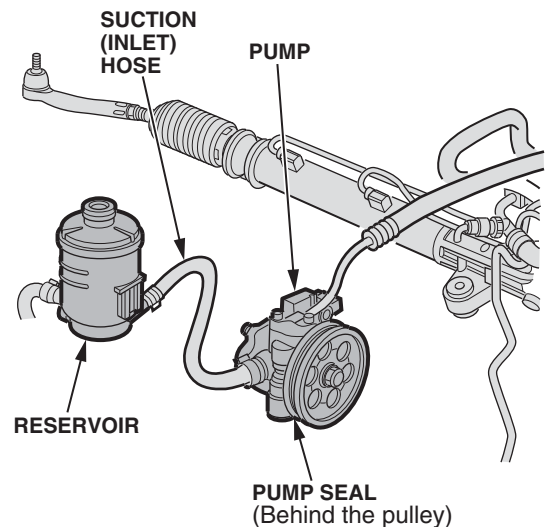
On all Hondas with power steering, a pin hole leak between the reservoir and the suction (inlet) side of the pump can cause the power steering fluid in the reservoir to foam and overflow. When air is sucked into the system, it mixes with the fluid and causes it to foam. This foaming can also cause the pump to growl. Pin hole leaks are hard to diagnose because they let air in but they don't leak fluid out. So, if you suspect a pin hole leak, try this:

1. Start the engine, and let it warm up to operating temperature.
2. Adapt a hand pump to fit into the reservoir opening. (If you're using a Mighty-Vac pump, it comes with adapters to do this.)
3. With the engine idling, connect the hand pump to the reservoir, and pressurize the reservoir to a maximum of 8 psi.
4. Look for a leak in the suction (inlet) hose or at the pump seal. Repair the power steering system as needed.

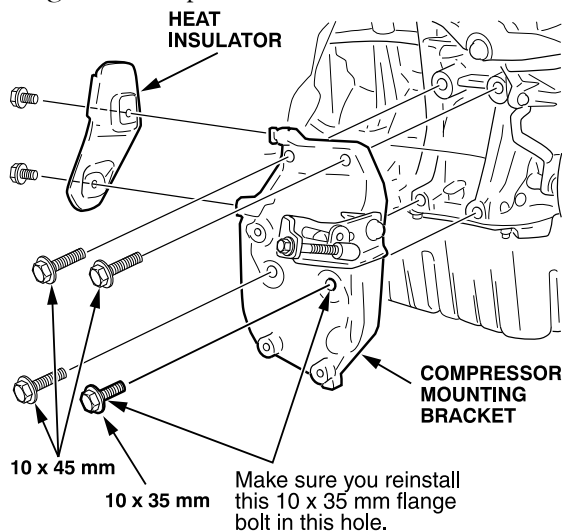
In step 17 of the '01 Civic A/C installation instruction (AII 21888-22262), you must remove the A/C compressor bracket to install the heat insulator. Three of the A/C compressor bolts are 10 x 45 mm and one is 10 x 35 mm. When you reinstall the compressor bracket, make sure you reinstall the 10 x 35 mm bolt in the *lower right* bolt hole in the bracket. If you install one of the longer 10 x 45 mm bolts in that hole, the bolt head will damage the compressor.

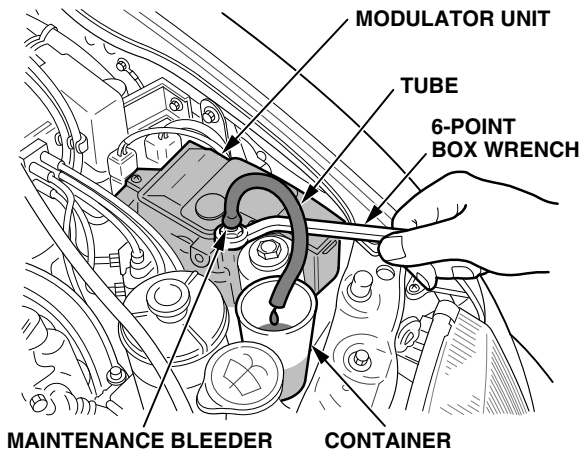
On '94–97 Accords and '95–97 Odysseys, when the ABS self-test detects a faulty accumulator, the ABS control unit sets a DTC 1-8 (accumulator volume problem). Before you replace any ABS components, do these steps first:

1. Bleed the high-pressure brake fluid from the modulator unit (see the ABS section of the appropriate service manual). Measure the quantity of brake fluid collected when the system pressure is relieved.
 - If the accumulator gas pressure is *zero*, you'll collect about 5 cc of fluid.
 - If the accumulator gas pressure is *low*, you'll collect up to 75 cc of fluid.
 - If the accumulator gas pressure is *OK*, you'll collect 35 to 45 cc of fluid.

2. If the accumulator contains less than 35 cc or more than 45 cc of fluid, refer to S/B 93-038, *ABS Light Comes On*, filed under Steering/Brakes/Suspension, and carefully bleed the system.
3. Remeasure the accumulator fluid volume. If the accumulator fluid volume is *still* not within 35 cc to 45 cc after bleeding, replace the accumulator.

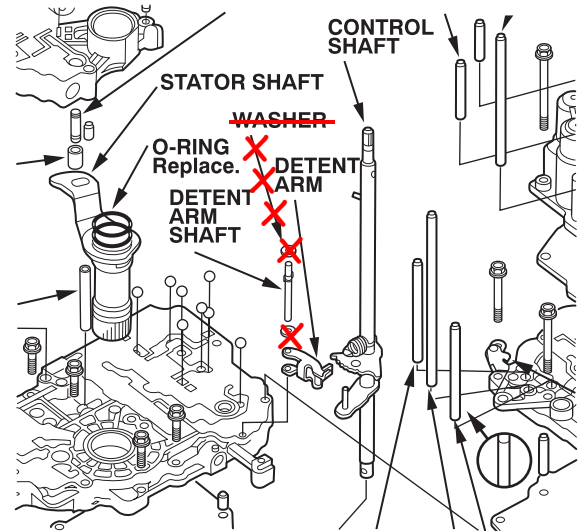
Pages 14-144 and 14-174: Change the Exploded Views to look like this:

The Automatic Transmission section of the '01 Civic S/M calls out washers for the detent arm shaft. There are *no* washers used for the detent arm shaft in '01 Civics. Make these changes in your copies of the S/M:

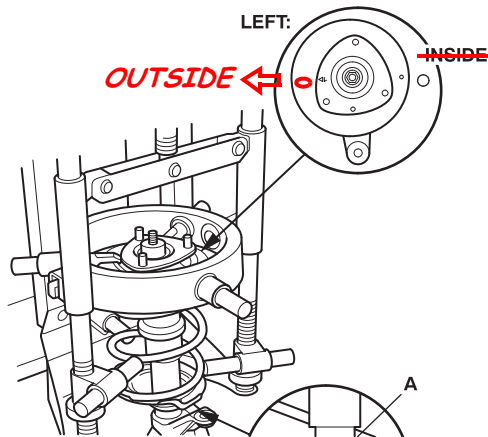
Page 18-22, Reassembly, step 1: Change the text and illustration to read and look like this:

In the '01 Civic S/M, step 1 on page 18-22 and on page 18-23 has the wrong orientation for the upper spring seat. Make these changes in your copies of the S/M:

The hole in the upper spring seat and the arrow on the damper mounting base must point toward the knuckle mounting area.

1. Install all the parts except the self-locking nut onto the damper unit by referring to the Exploded View. Align the bottom of the spring (A) and the stepped part of the lower spring seat (B) as illustrated. ~~Align the upper spring seat so that the small hole in it is on the engine compartment side when it is installed in the body.~~

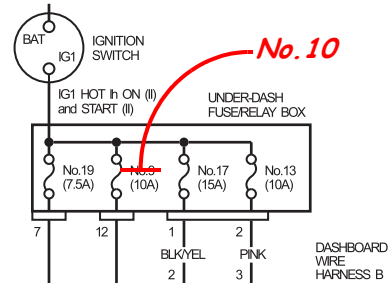
Page 23-32: Change the circuit diagram to look like this:

The Restraints section of the '01 Civic S/M has the wrong fuse number called out in the driver's under-dash fuse/relay box. The No. 19 (7.5 A) fuse should be No. **10** (7.5 A). Make sure you include these changes in your copies of the S/M:
