Torque Converter Shudder or Vibration Between 35 and 40 MPH (Supersedes 06-003, dated February 2, 2006, to update the information marked by the black bar)

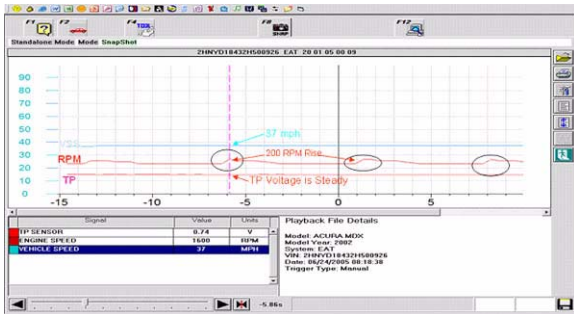
1. To confirm the client's complaint, test-drive the vehicle on a smooth road, preferably with a slight incline. Set the cruise control between 35 and 40 mph, and monitor the engine rpm using the vehicle's tachometer, or use the HDS to take a snapshot of the engine rpm.

2. If the engine speed fluctuates several hundred rpm while maintaining a constant vehicle speed, disconnect the EGR valve and retest the vehicle.
 - If the fluctuation is gone, refer to the EGR troubleshooting in the service manual.
 - If the engine rpm still fluctuates, and the transmission does not have any other symptoms (shifting problems, slipping, transmission DTCs) go to step 3.
3. Drain the transmission fluid, then strain it through a paint strainer.
 - If you find little or no contamination in the strainer, the ATF is OK, even if it smells burnt, is discolored, and/or the magnetic drain plug has small chips, flakes, or metal fuzz on it. Go to **REPAIR PROCEDURE A**.
 - If you find large amounts of contamination (pieces of metal or friction material) in the strainer, go to **REPAIR PROCEDURE B**.
