Bulletin No.: 06-02-32-007G

Date: April 05, 2010

Subject: Clunk, Knock or Rattle Noise From Front of Vehicle While Driving or Turning Over Bumps at Low Speeds (Diagnose Noise and Perform Outlined Repair)

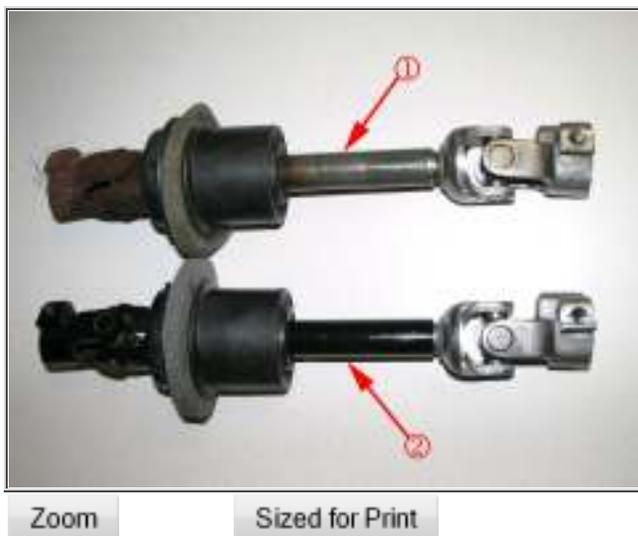
Electric Assist [Power Steering](#)

First Design - Bare Steel Tube (Lube OK)

Second Design - Black Painted (DO NOT Lube)

In the unlikely event that the source of the noise is identified as a second design shaft with black painted tube, it must be replaced.

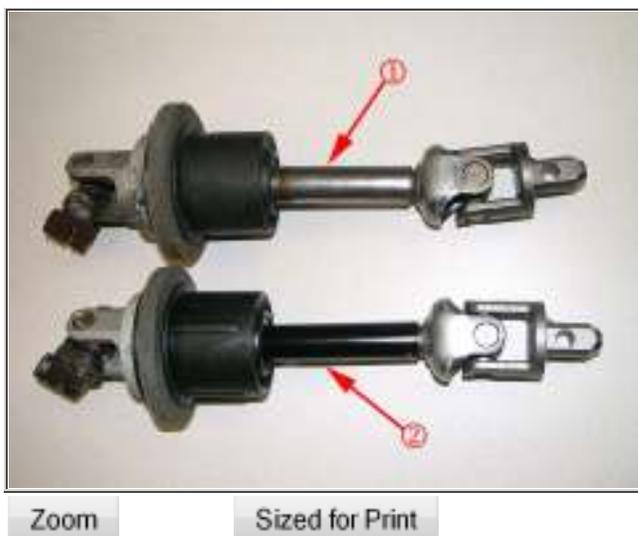
Hydraulic Assist [Power Steering](#)

First Design - Bare Steel Tube (Lube OK)

Second Design - Black Painted (DO NOT Lube)

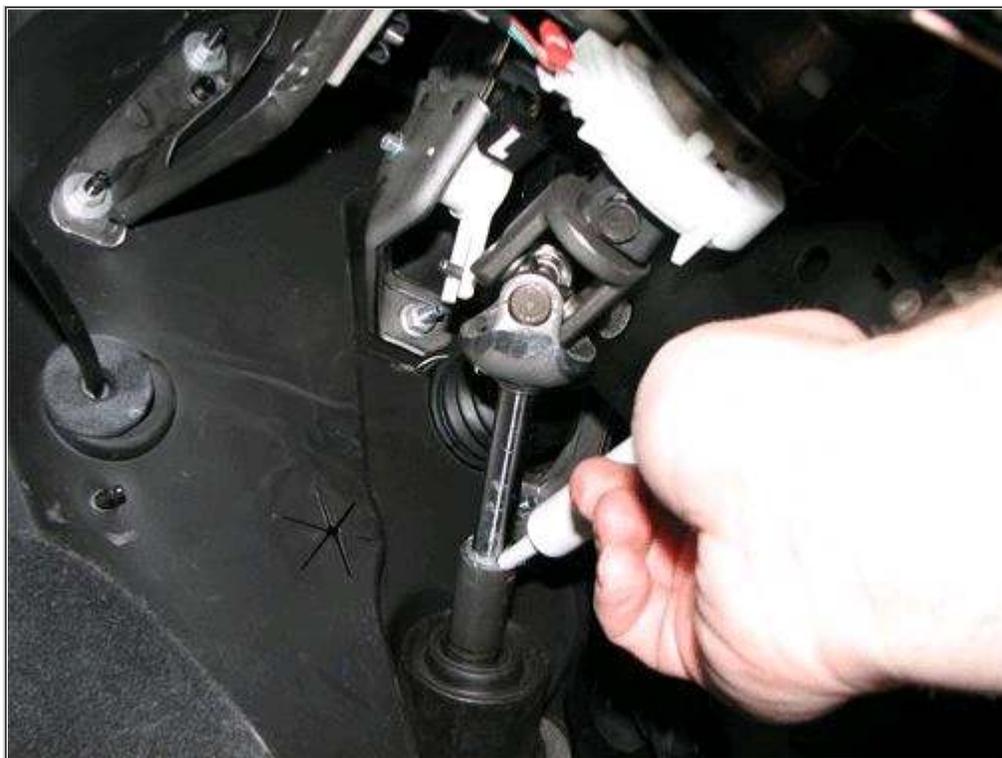
The clunk noise may be caused by a slip/stick condition between the inner and outer components of the intermediate shaft.

2. Remove the intermediate shaft to [steering column](#) attachment bolt.
3. Remove the intermediate shaft from the [steering column](#).

4. Extend the intermediate shaft all the way. Using the intermediate shaft grease kit, P/N 26098237, inject the grease into the gap between the inner shaft and the outer shaft as you are collapsing the shaft. This will draw the grease into the shaft.
5. Cycle the shaft up and down several times to distribute the grease.

Remove original thread locker material from the bolt and apply Loctite(R) 242 (or equivalent) to the threads of the bolt and reinstall intermediate shaft bolt.

- For electronic [power steering](#), tighten the bolt to 49 Nm (36 lb ft).
- For hydraulic [power steering](#), tighten the bolt to 62 Nm (46 lb ft).

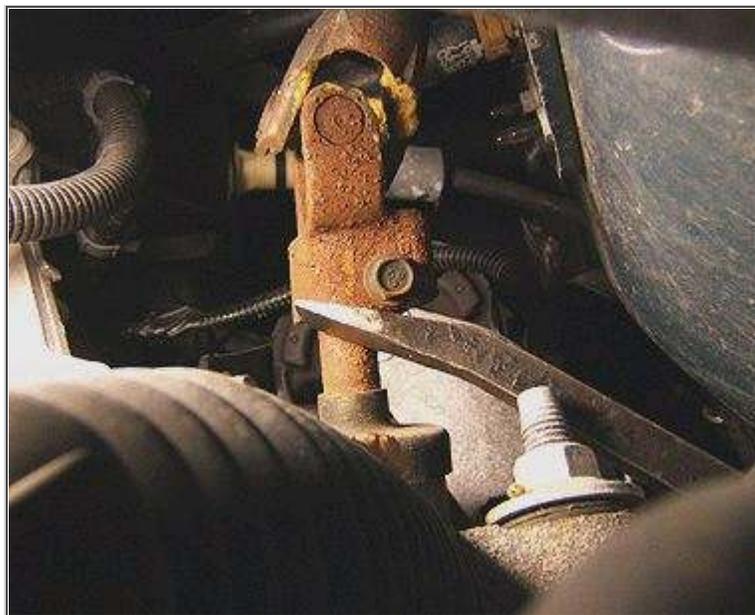
There may be interference between the clamp and the [steering gear](#) input shaft. The clamp is beveled and if forced down on the input shaft too hard, it may cause a loose fit with the intermediate shaft to input shaft joint.

1. Remove the intermediate shaft pinch bolt at the [steering gear](#) end.
2. Install a new bolt, GM P/N 07845238, but do not tighten the bolt at this time.

3. Pry the clamp up using a pry bar to position the bolt into the upper part of the groove as shown above. This will position the clamp off the bevel.
4. While keeping the clamp in the upper position, tighten the bolt.

Tighten the bolt to 49 Nm (36 lb ft).

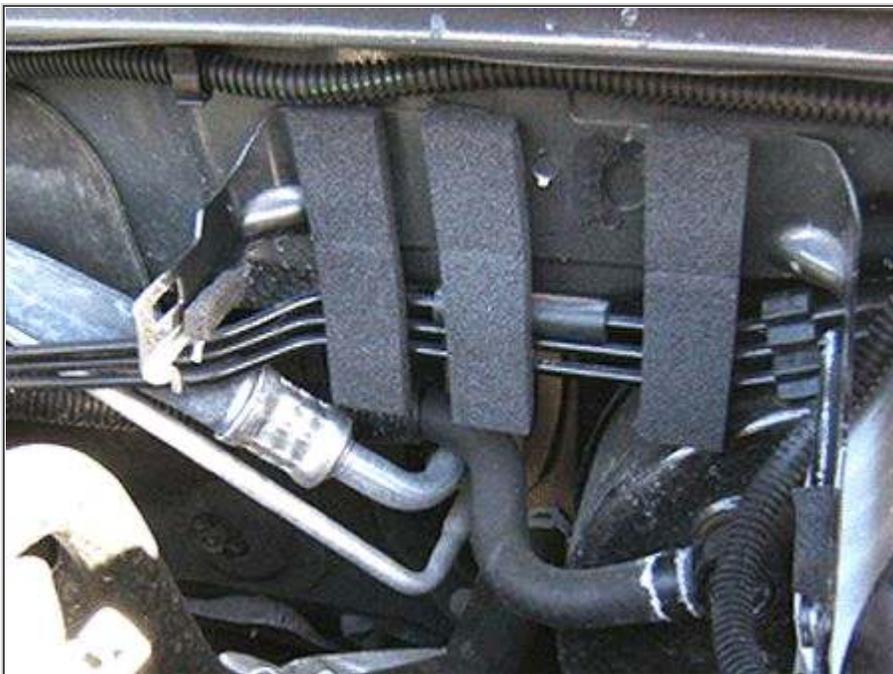
Some customers may comment on a knocking or rattling type noise from the front of the vehicle when driven at low speeds and over bumps. The noise only occurs when the [steering wheel](#) is in the straight ahead position and sounds like the noise is in the left [suspension](#) of the vehicle or directly in front of the driver.

5. If the noise is coming from the radiator surge tank, release the two retaining tabs holding the radiator surge tank and reposition the tank away from the attaching bracket and isolate with closed cell foam.

6. Cut three pieces of closed cell foam, P/N P46515 (or equivalent), into 25 mm (1 in) by 102 mm (4 in) pieces.
7. Cut two pieces of closed cell foam into 25 mm (1 in) by 6 mm (1/4 in) pieces.

8. Install the three pieces of foam to the attaching bracket starting at the top center inside the bracket and proceed down across the fuel lines, then at the inside of the bracket at the left and right positions of the center piece of foam. Finally, install the

last two pieces of foam to the inside bracket at the left and right extended sides behind the retaining holes as shown above.
