HONDA ENGINES

OVERHEAD-VALVE ENGINE #37

ENGINE DISTRIBUTORS SERVICE BULLETIN

GX610K1 • GX620K1 • GX670 GXV610K1 • GXV620K1 • GXV670 LOW OIL PRESSURE

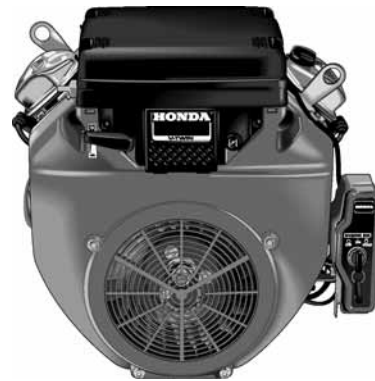
Improper seal between the oil pump cover and the engine side cover causes a reduction in oil pressure.

The oil pump cover does not effectively seal with the engine side cover; this prevents the oil pump from priming, or causes a reduction in oil pressure. At high engine temperatures, the poor seal allows the oil pressure to bleed off. Affected units with the described symptom should first be inspected to determine if the problem is the result of inadequate maintenance. Proceed to the next page for inspection procedures.

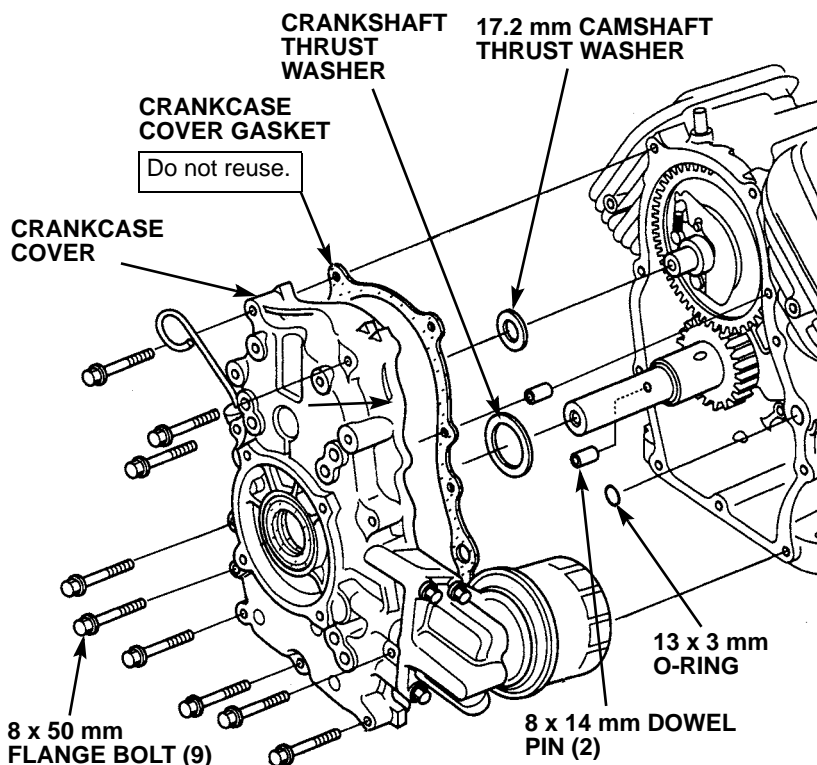
1. Drain the engine oil and dispose of used oil properly.
2. Remove the engine from the OEM piece of equipment (as necessary).
3. Rotate the engine to bring the #1 cylinder to TDC (on the left when facing the engine PTO).
4. Remove the nine 8 x 50 mm flange bolts and the crankcase cover.

The oil cooler mounting bolts may have to be loosened to remove the case cover (if applicable).

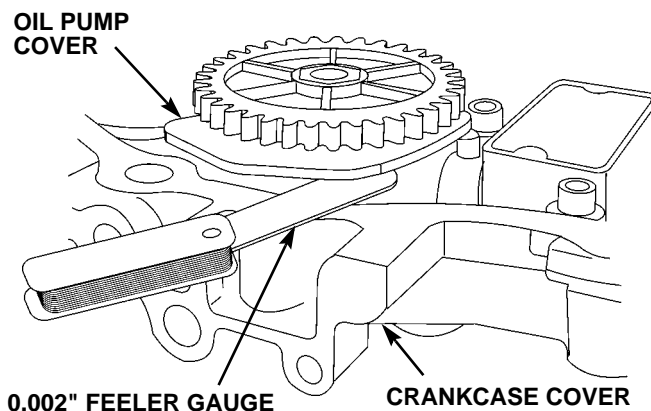
OIL PUMP INSPECTION

Inspect for a gap between the oil pump cover and oil pump case using a 0.002" feeler gauge.

- If a 0.002" (0.05 mm) feeler gauge fits between the oil pump cover and the crankcase cover, proceed to the REPLACEMENT section (next page).
- If the feeler gauge does not slide between the two surfaces, this bulletin is not applicable.

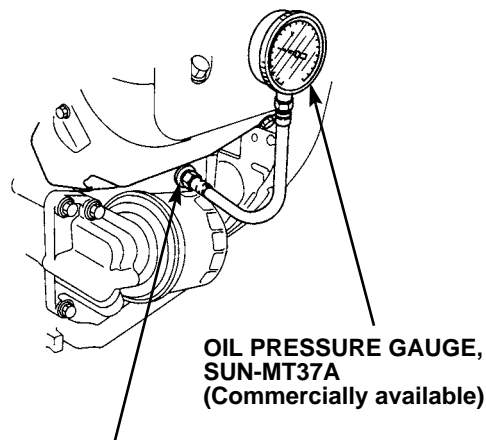
**OIL PRESSURE GAUGE,
SUN-MT37A
(Commercially available)**

**ADAPTER, 1/8 x 28 BSPT,
SUN-AT77AH
(Commercially available)**

16. Install an oil pressure gauge (commercially available).

17. Crank the engine and check the oil pressure rises as the engine starts. With the engine at idle, the minimum oil pressure should be 12 psi (0.84 kgf/cm²).
