2001 - 2004 PATHFINDER; DRIVER'S SEAT (WITH ADP ONLY) WON'T MOVE FORWARD OR BACKWARD

TECHNICAL SERVICE BULLETIN

Reference Number(s): NTB00-095a, Date of Issue: December 21, 2004
NISSAN: 2001-2004 Pathfinder (R50) equipped with ADP

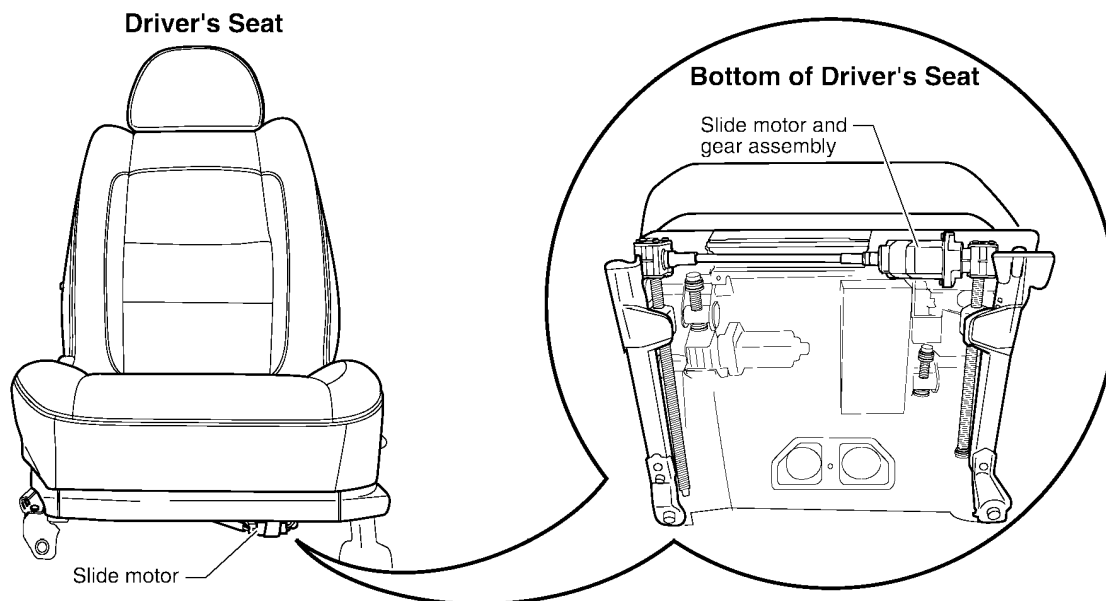
G03360696

[Fig. 1: Identifying Driver's Seat Slide Motor And Gear Assembly](#)

1. Confirm this bulletin applies (see steps [1](#) and [2](#) of the Service Procedure).
2. If needed, install the Seat Slide Motor Kit (see Parts Information).

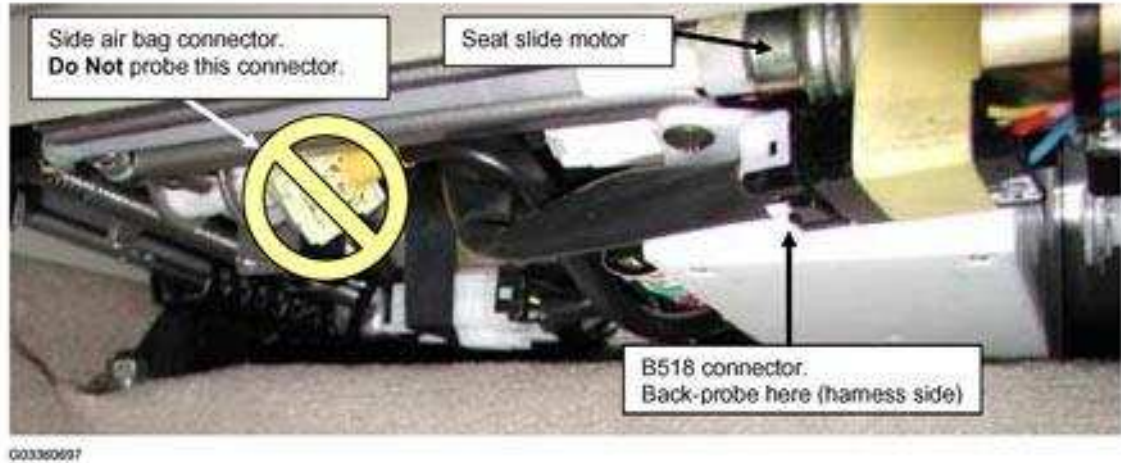
1. Using the power seat switch, tilt the front edge of the seat bottom all the way up.
2. Check voltage to the seat slide motor as follows:
 - Measure voltage between terminal 1 ("BR" wire) and terminal 2 ("W/B" wire) in the seat slide motor connector (B518).
 - See [Fig. 2](#) . For more detailed information, refer to "Automatic Drive Positioner" in the EL section of the appropriate Service Manual (ESM).

WARNING: When checking the power seat slide motor circuit, do not confuse its black connector (B518) with the side air bag module yellow connector.

Fig. 2: Checking Voltage To Seat Slide Motor

- This voltage check can be done with the seat slide motor connected.
 - If the voltage is about 12V when the seat slide switch is pressed to the "forward" and "backward" positions this bulletin applies, proceed to step 3.
 - If voltage is 0V when the seat slide switch is pressed to **either** the "forward" or "backward" positions, this bulletin does not apply. Use the EL section of the appropriate Service Manual (ESM) to further diagnosis and repair the incident.
3. Record the radio station pre-sets for later reprogramming after the procedure.

4. Lightly tap the seat slide motor (see [Fig. 2](#)). Sometimes this will get the motor working again temporarily so the seat can be moved to access the seat mounting bolts.

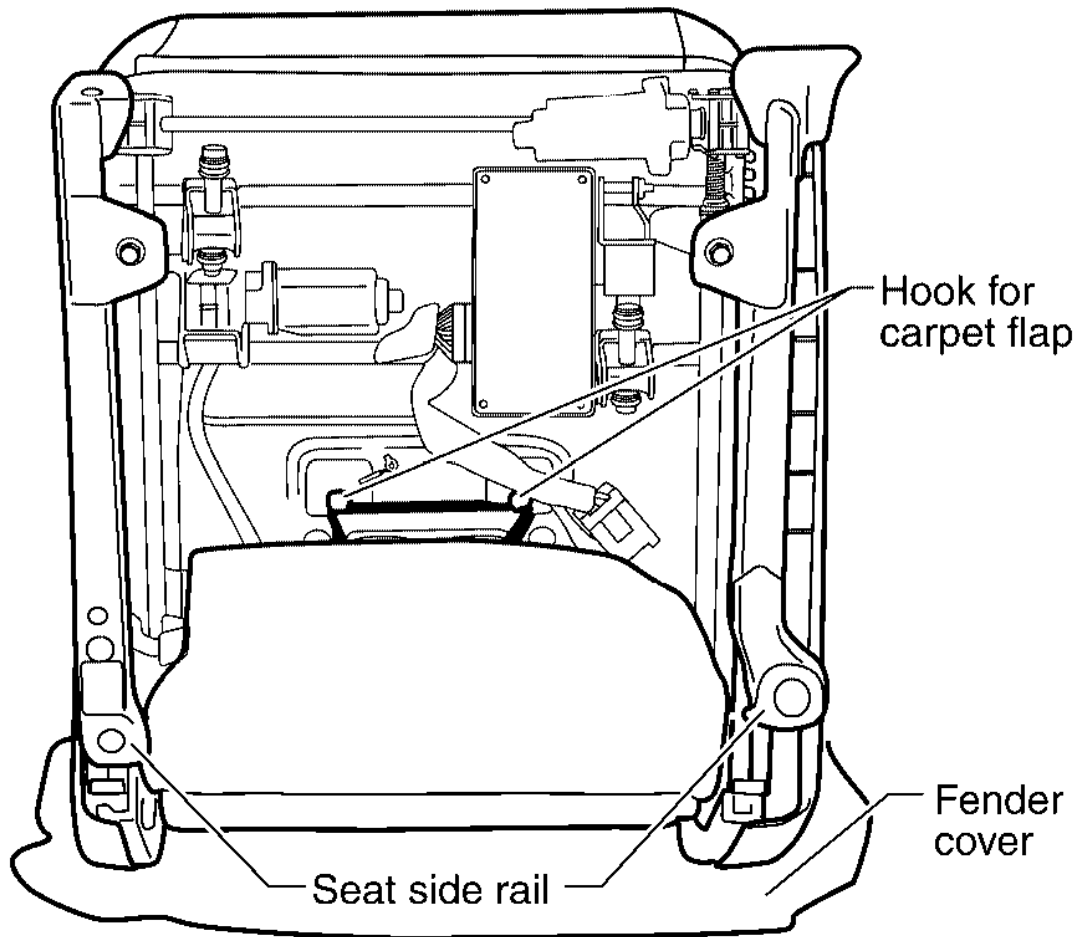
G03360698

11. Unhook the carpet flap from the underside of the seat bottom (see [Fig. 3](#)).

Fig. 3: Unhooking Carpet Flap From Underside Of Seat Bottom

28. Re-connect the slide motor electrical connector (B518), making sure it snaps in place.
29. Re-hook the strap to attach the carpet flap onto the bottom of the seat (refer to [Fig. 3](#) if needed).

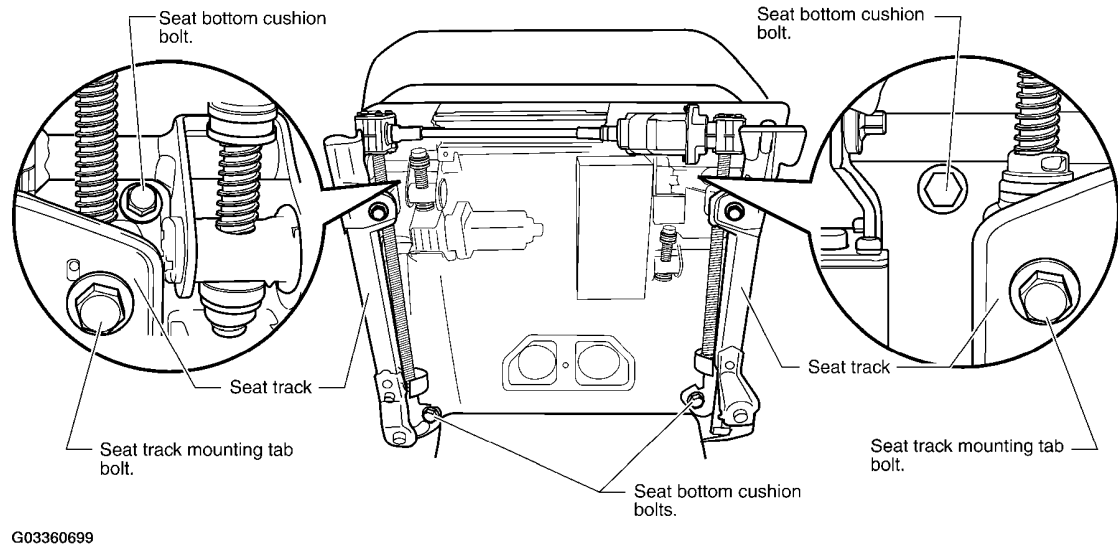
12. Remove the four seat bottom cushion bolts (M8, 12 mm head). These will release it from the seat frame (see [Fig. 4](#)).
 - Then, remove the two seat track mounting tab bolts (M6, 10 mm head), one on each side (see [Fig. 4](#)).
 - Removing these bolts will release the seat slide rails from the "worm gears".

Fig. 4: Removing Seat Bottom Cushion Bolts

25. Tighten bolts (M6, 10 mm head) into both seat track mounting tabs (see [Fig. 4](#)). Bolt torque: 65-84 in-lb (7.3-9.4 N.m).
26. Re-install screws to attach the side finishers and the front finisher (refer to [Fig. 5](#) if needed).

27. Re-install four bolts (M8, 12 mm head) to tighten the seat bottom cushion to the seat frame (refer to [Fig. 4](#) if needed). Bolt torque: 13-17 ft-lb (17.5-23.7 N.m).

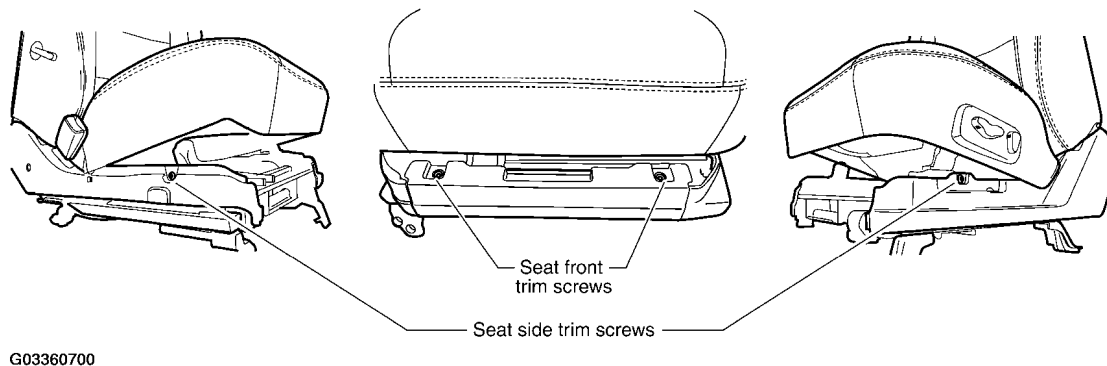
13. Remove both screws and finisher from the front edge of the seat (see [Fig. 5](#)).

Fig. 5: Removing Screws And Finisher From Front Edge Of Seat

14. Remove the top screw only from the RH & LH side finishers (see [Fig. 5](#)).
15. Disconnect the seat sub-harness connector to slide motor (see [Fig. 6](#)).
 - Remove the bolts shown below, one from each side of the seat frame (M8, 12 mm head). They're located at the sides of the front edge of the seat (see "Remove this bolt first" in [Fig. 6](#)).
 - Then, remove six nuts (3 on each side) and two base plates, located at the top of the frame, to release the gear boxes (see [Fig. 6](#)).

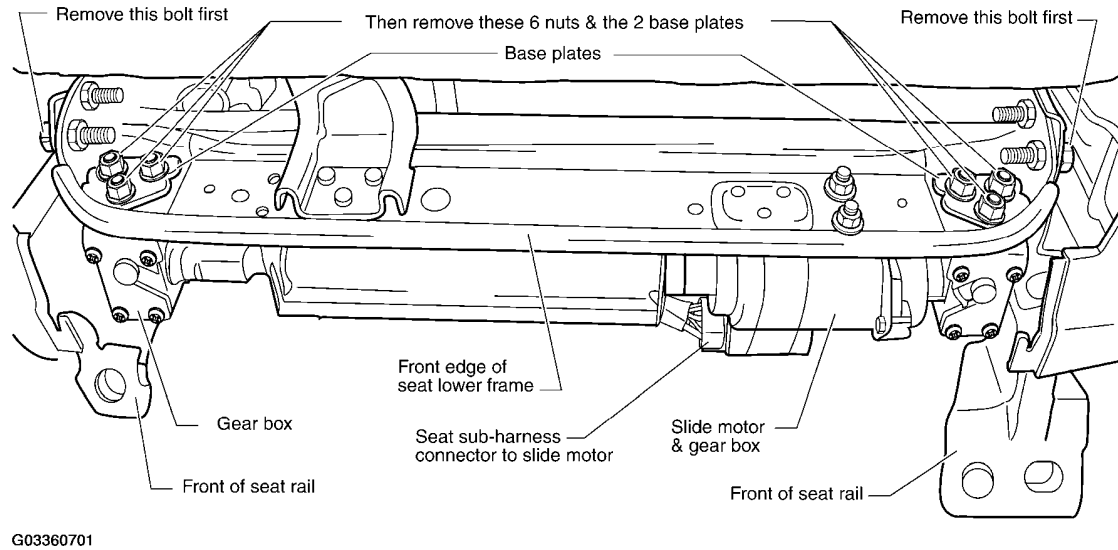
Fig. 6: Disconnecting Seat Sub-Harness Connector To Slide Motor

NOTE: For steps 20 through 23 (below), refer to [Fig. 6](#) and [Fig. 7](#) , if needed.

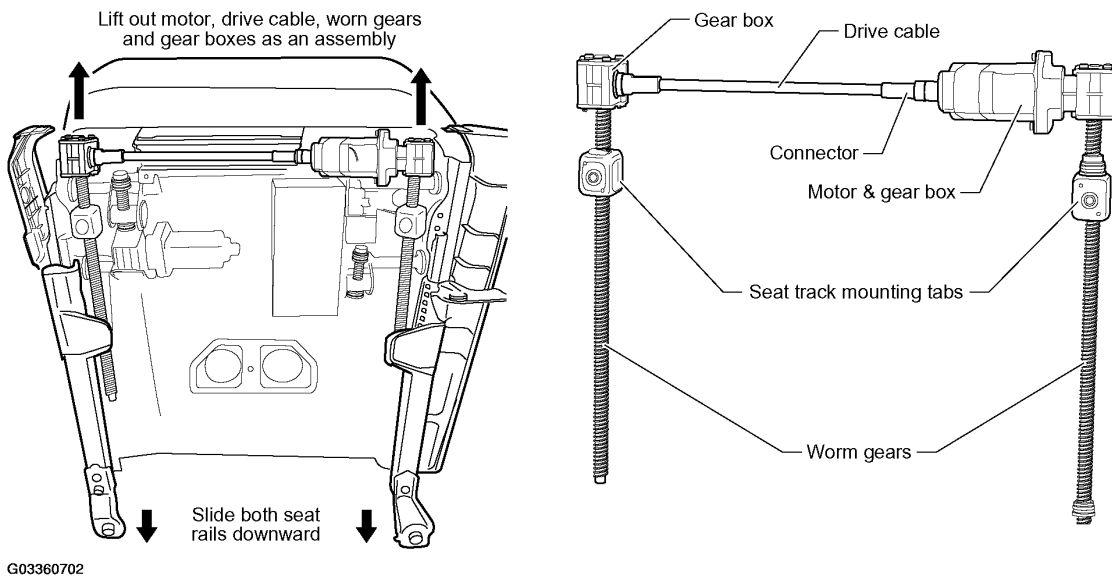
- Slide both sides of the seat rail **back** to the rear position (towards the seat back) and remove the worm gears, drive cable, motor, and gear boxes, all as one unit, from the seat adjuster assembly. (see [Fig. 7](#)).

CAUTION: Avoid bending the drive cable. Bending the cable will result in noise during seat operation.

Fig. 7: Removing Worm Gears, Drive Cable, Motor & Gear Boxes

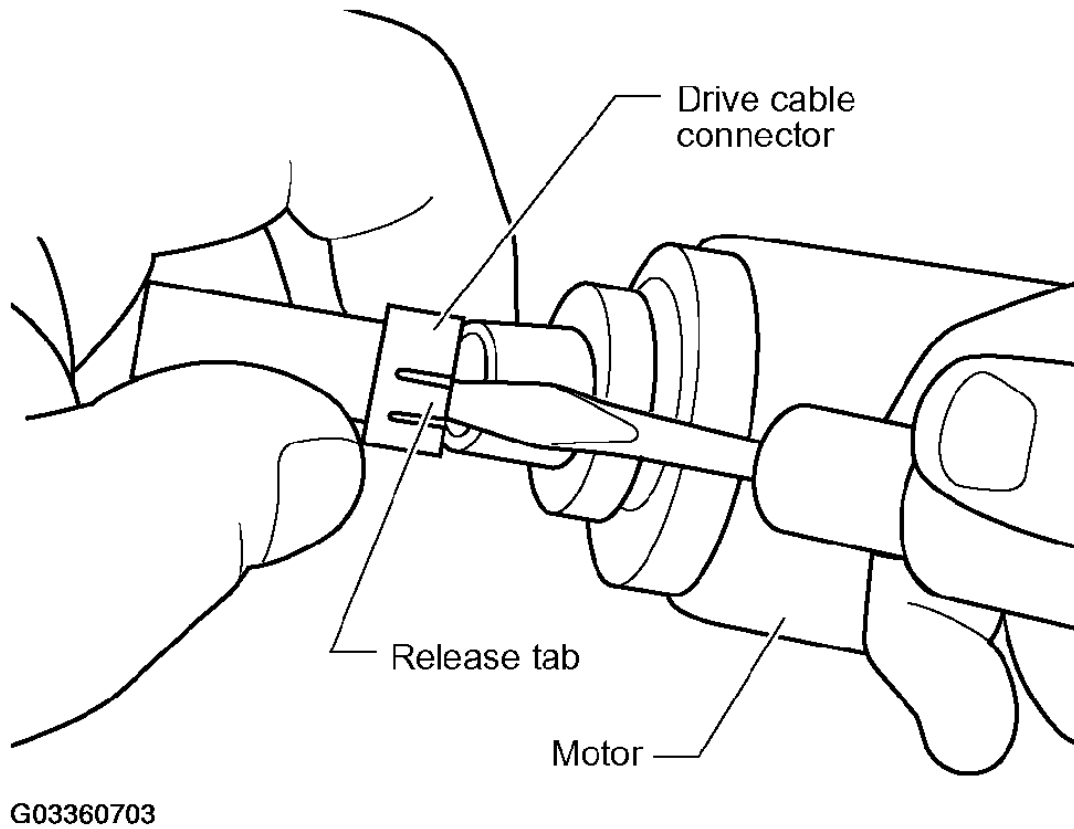
- Remove the drive cable from the gear boxes. To release the drive cable from the motor end, pull up on

the tab using a small flat blade screwdriver or equivalent (see [Fig. 8](#)).

[Fig. 8: Removing Drive Cable From Gear Boxes](#)

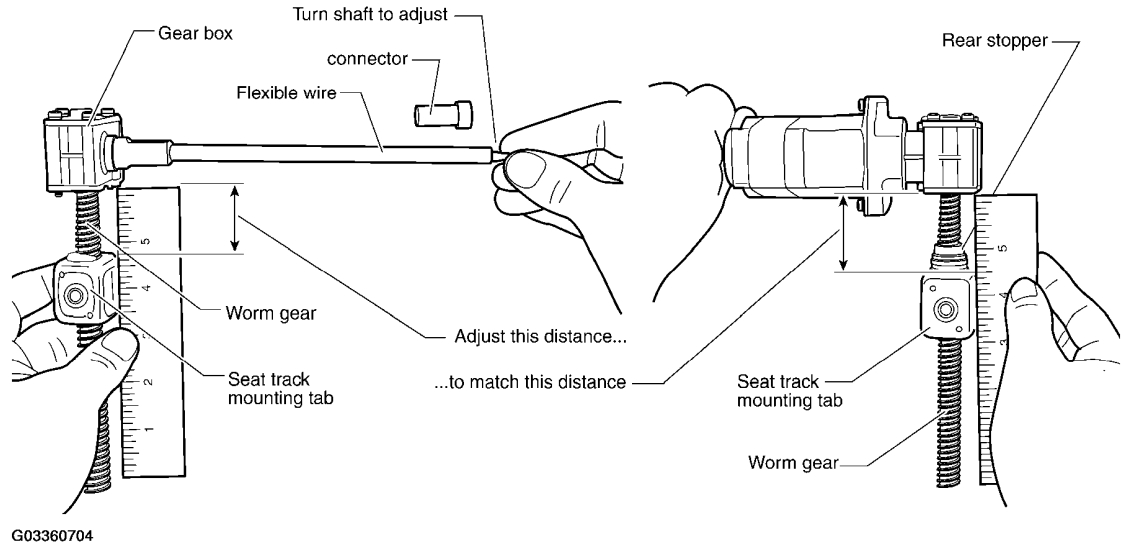
18. Make sure the new seat track mounting tab is touching the rear stopper, with the threaded shaft facing up (see [Fig. 9](#)).
 - Measure the distance between the gear box and the mounting tab (see [Fig. 9](#)).
 - Measure and adjust the other seat track mounting tab to the same distance (see [Fig. 9](#)).

Fig. 9: Proper Positioning Of Seat Track Mounting Tab

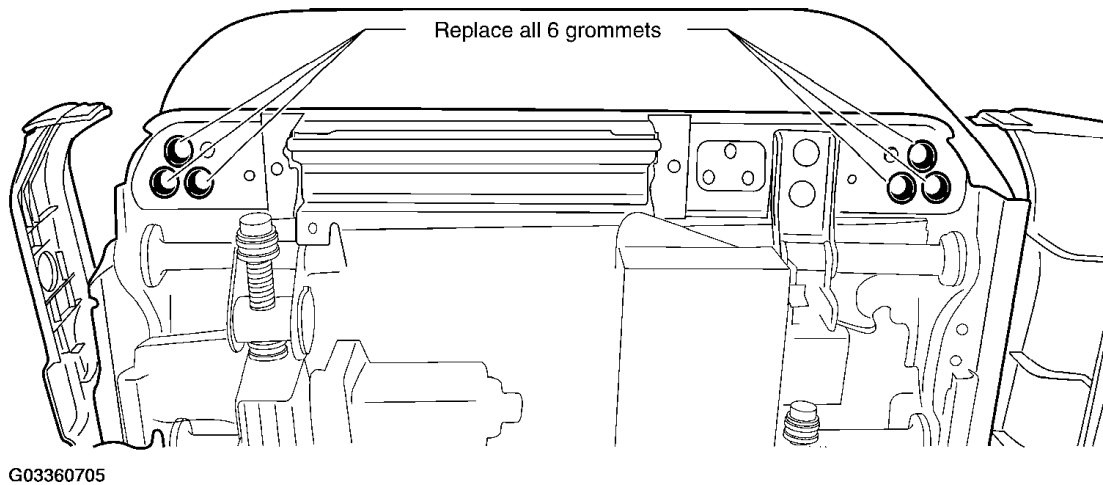
19. Replace all six rubber grommets (3 to each side) from the kit (see [Fig. 10](#)).

Fig. 10: Replacing All Six Rubber Grommets From Kit

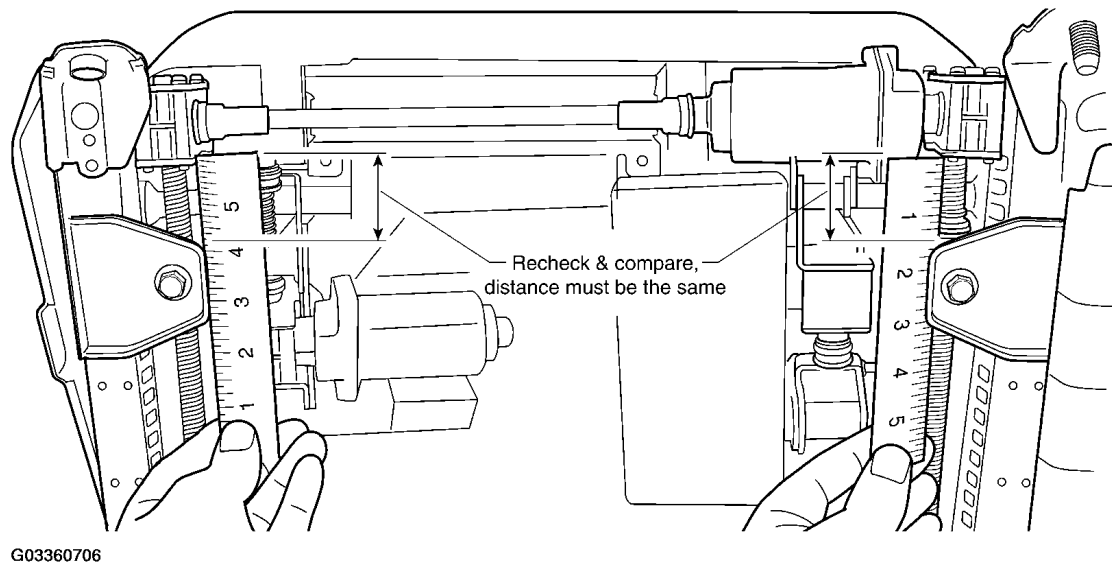
21. Move both seat tracks back into position on top of the seat track mounting tabs. Install and hand tighten the bolts into both seat track mounting tabs (M6, 10 mm head).
22. Tighten the six nuts (three on each side) with the base plates, located at the top of the frame, to secure the gear boxes (refer to [Fig. 6](#) if needed). Nut torque: 64-85 in-lb (7.17-9.69 N.m).
23. Re-install and tighten two bolts (M8, 12 mm head) located to the sides of the front edge of the seat frame (see "Remove this bolt first" in [Fig. 6](#)). Bolt torque: 13-17 ft-lb (17.5- 23.7 N.m).
24. Check the gear box to mounting tab distance again. Make sure the distance has not changed (see [Fig. 11](#)).
 - If N/G, adjust.

[Fig. 11: Checking Gear Box To Mounting Tab Distance](#)
