Technical Bulletin

Model(s)	Year	Eng. Code	Trans. Code	VIN Range From	VIN Range To
(B5) Passat, Passat Wagon	1998 – 2004	(1.8L) AEB, ATW, AUG, AWM	All	All	All

17 09 06 May 18, 2009 **2013233** Supersedes T. B. Group 17 number 09-03 dated Mar. 20, 2009 due to updated warranty table.

Engine Oil Pressure Too Low, Light is ON, Engine Flush

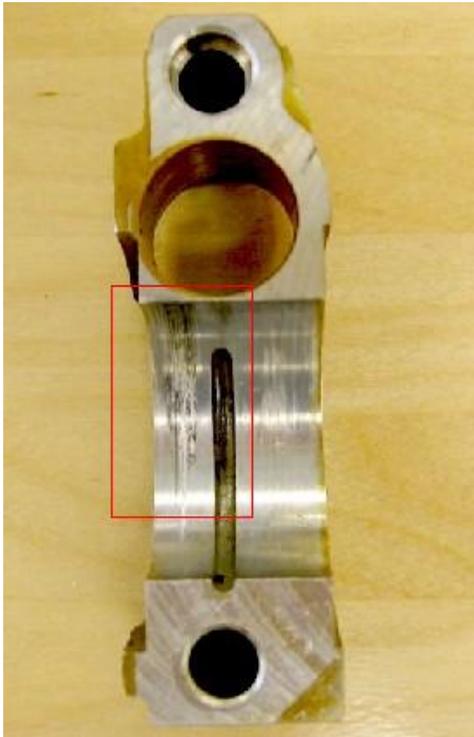
- Place the vehicle in "service position".
- Remove cylinder head cover.
- Remove plastic oil deflectors from the top of intake camshaft.
- Inspect all camshaft bearings (remove only one cap at a time) for damage.

If one or more camshaft bearings are damaged, the complete engine must be replaced as described in “**Engine Replacement Guidelines**” section.

If **ALL** camshaft bearings are okay (**NOT** damaged), the engine must be repaired as described in “**Engine Repair Guidelines**” section.

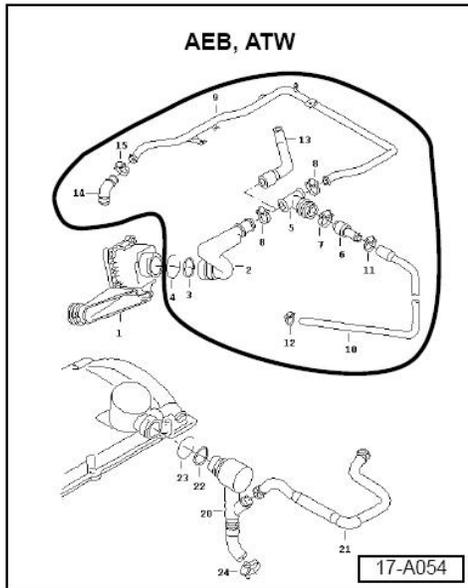
For Engine code AEB, ATW

- Replace crankcase ventilation system hoses and pressure regulating valve depending on engine code (see circled items and compare to latest Parts Dept. illustration).
- Replace O-rings, clamps and miscellaneous fasteners only as necessary.

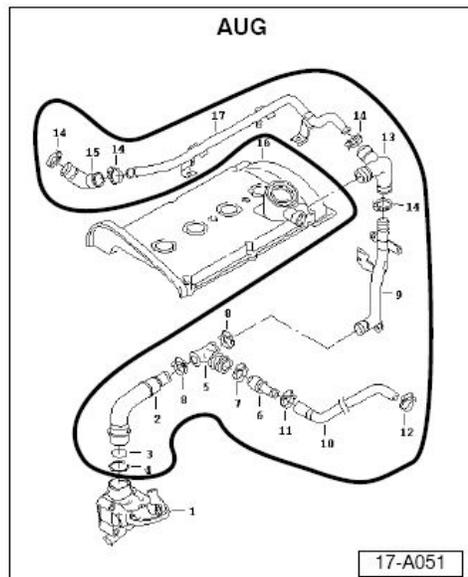
For Engine code AUG

- Replace crankcase ventilation system hoses, pipes and pressure regulating valve depending on engine code (see circled items and compare to latest Parts Dept. illustration).
- Replace O-rings, clamps and miscellaneous fasteners only as necessary.

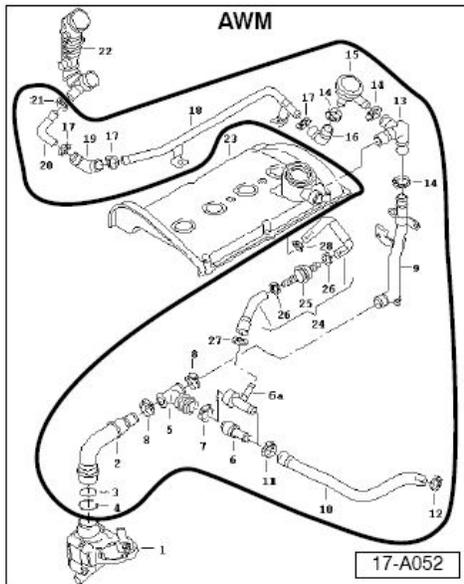
For Engine code AWM

- Replace crankcase ventilation system hoses, pipes and pressure regulating valve depending on engine code (see circled items and compare to latest Parts Dept. illustration).
- Replace O-rings, clamps and miscellaneous fasteners only as necessary.

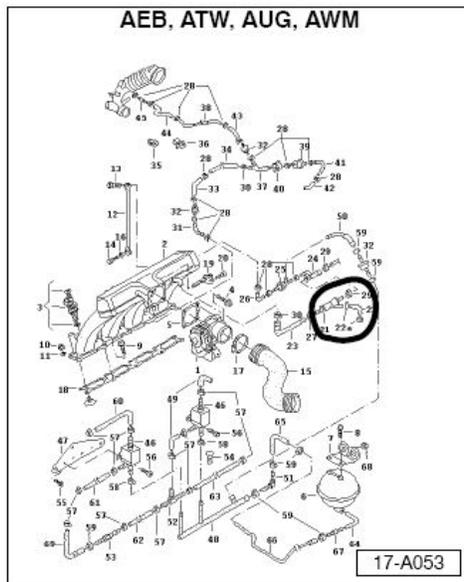
For All Vehicles

- Inspect and replace brake booster suction jet pump (circled) if clogged.
- Replace O-rings, clamps and miscellaneous fasteners only as necessary.

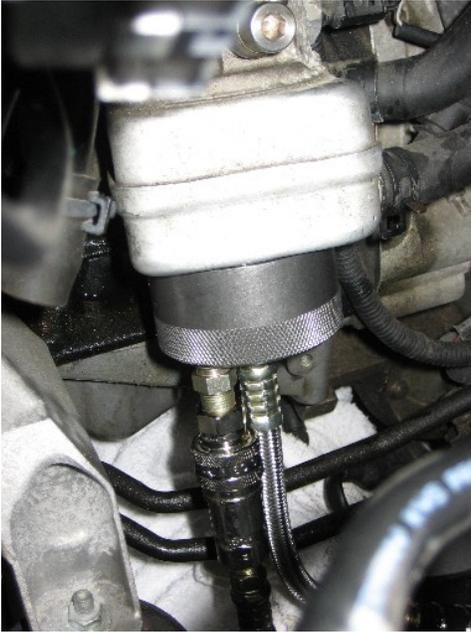
- Remove oil filter.
- Install oil filter adapter on oil filter holder.
- Connect oil lines from external oil filter assembly to oil filter adapter.

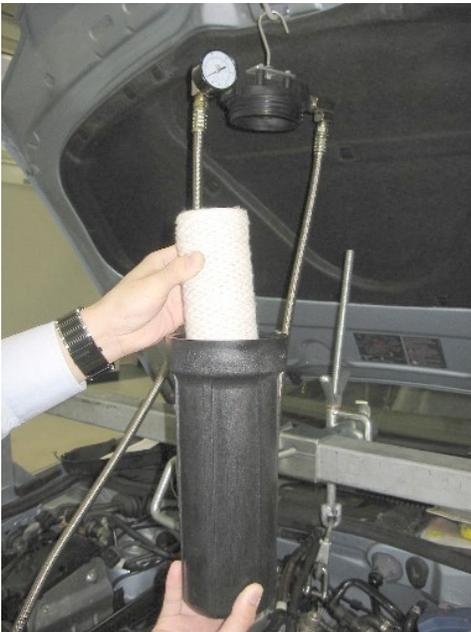
- Insert a new oil filter element in canister of external oil filter assembly.
- Partially fill (approximately 1 quart) canister of external oil filter assembly with engine cleaner, **DO NOT** overfill.
- Attach filled canister to external oil filter assembly and tighten securely.

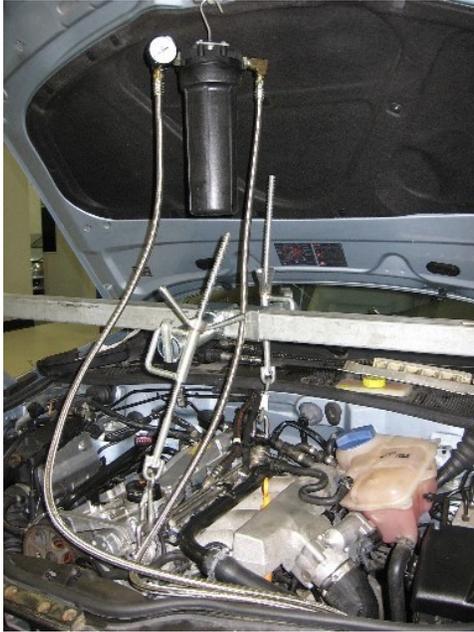
- Hook external oil filter assembly to engine hood latch.
- Pour remaining engine cleaner (total amount 6 quarts) into engine through oil filler cap.
