1998 Isuzu Truck Rodeo LS 2WD V6-3.2L

Removal Procedure

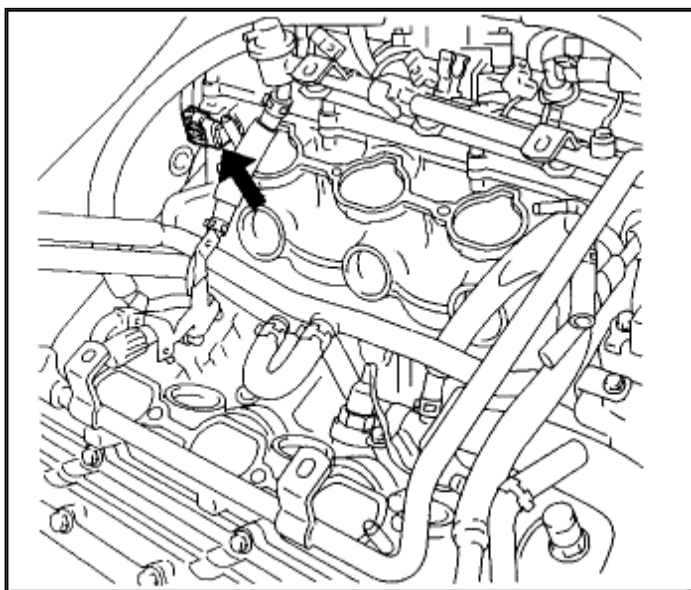
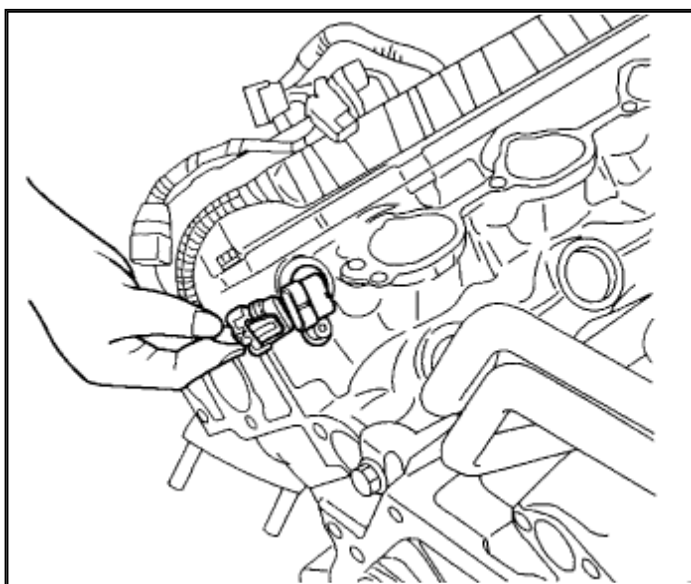
1. Disconnect the negative battery cable.
2. Remove the engine cover.
3. Remove the common chamber assembly. Refer to Common Chamber in Engine Mechanical.
4. Disconnect the electrical connector to the CMP sensor.
5. Remove the CMP retaining bolt from the side of left cylinder head.
6. Remove the CMP sensor from the cylinder head.
