2005 Hyundai Truck Tucson V6-2.7L

AUDIO ASSEMBLY REPLACEMENT

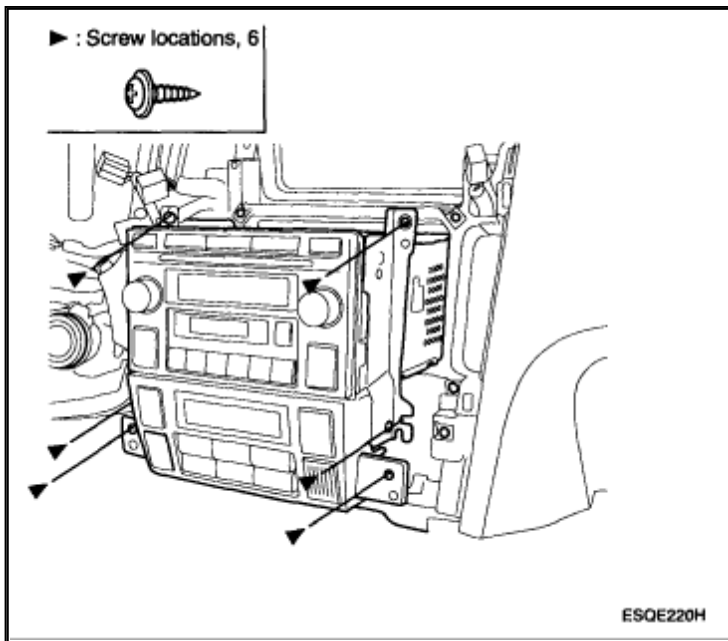
1. Remove the center facia panel.
2. Loosen the screws.
