**1992 Acura Legend Sedan V6-3206cc 3.2L SOHC FI**

**Service and Repair**

**STEREO RADIO/CASSETTE REPLACEMENT**

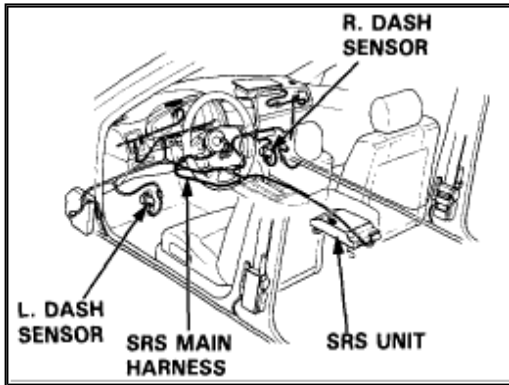
SRS wire harnesses are routed near the steering column and passenger's side dashboard.

- All SRS wiring harnesses are covered with yellow outer insulation.
- Before disconnecting any part of the SRS wire harness, install the short connectors.
- Replace the entire affected SRS harness assembly if it has an open circuit or damaged wiring.

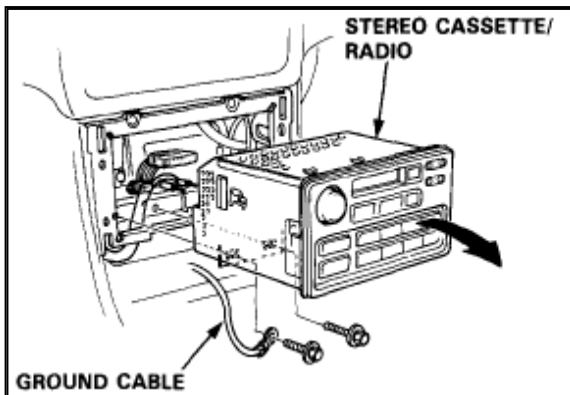
2. Remove the 2 mounting bolts, then disconnect the ground cable. Remove the stereo radio/cassette by pulling it Out of the console. **NOTE:**

3. Disconnect the connectors.

4. Installation is the reverse of the removal procedure. **NOTE:** Before tightening the mounting bolts, make sure the harnesses are not pinched.
