1992 Ford Truck E 150 Van L6-300 4.9L[Vehicle Level](#) → [Heating and Air Conditioning](#) → [Heater Core](#) → [Service and Repair](#) ←

Service and Repair

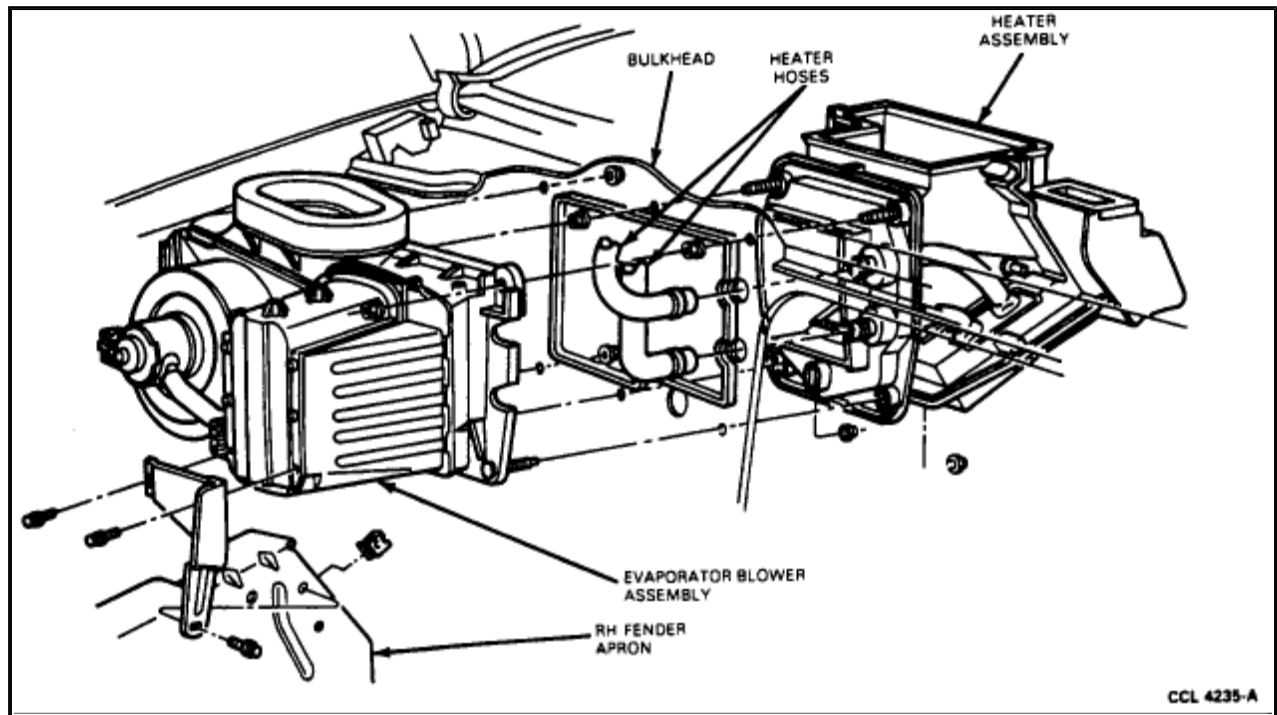
Heater Assembly

There are four carriage bolts which pass through holes in the instrument panel, located around the edges of a large cutout in the panel. This cutout is an opening between the heater blower housing assembly on the engine compartment side of the instrument panel and the evaporator core when air conditioning is provided as an option. This evaporator housing assembly includes other components which are common to heating and air conditioning-heating systems, on the passenger compartment side of the panel. Nut and washer assemblies draw the two major components together through their gaskets at the instrument panel.

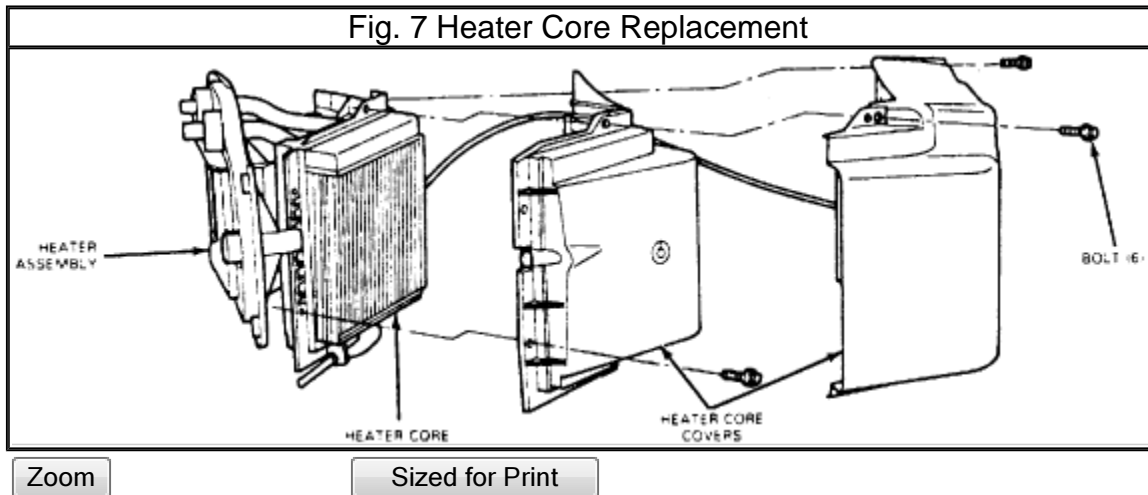
4. Remove the six screws from the heater core cover (18B300) **Fig. 7.** located on both sides of the heater assembly case.
5. Remove heater core cover.
6. Remove heater core and heater core case seal (18658) from the heater assembly.
7. Reverse procedure to install, refill [cooling system](#).

3. Remove modesty panel which runs along the lower edge of the instrument panel (04320).
