## Restraints - Rear Seat Belt Won't Retract Properly

Date: October 11, 2006  
Order No.: P-B-91.40/130  
Supersedes:  
Group: 91

## Restraints - Seat Belt Won't Retract Completely

Order No.: P-B-91.40/100

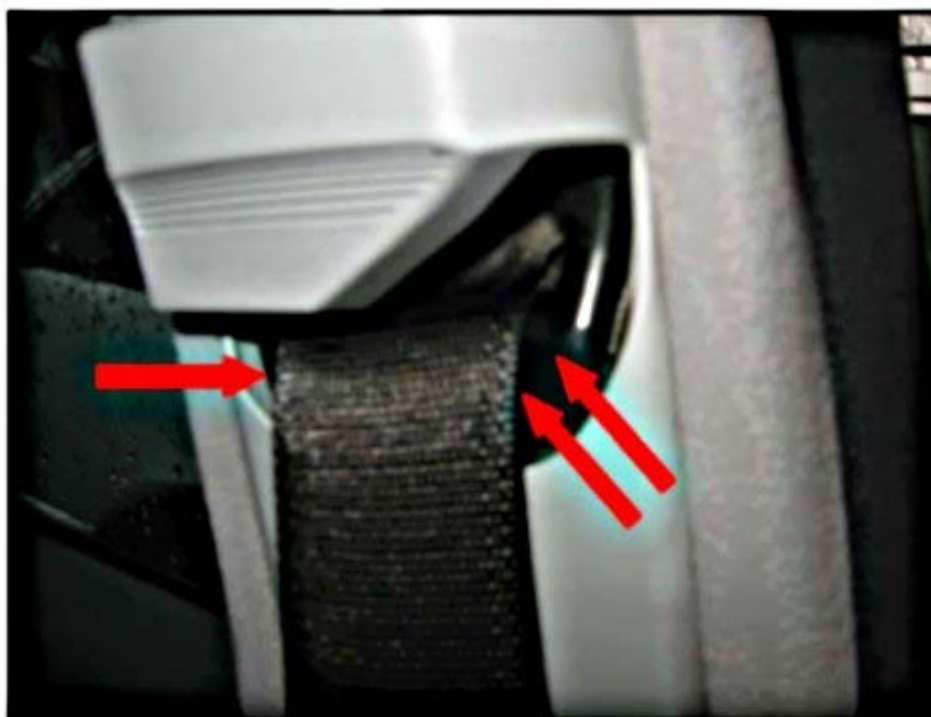
Figure 1

If you receive customer reports in the above model vehicles of the front or rear [seat belts](#) not rolling up fully, the cause could be dirt deposits on the seat belt guide due to a soiled seat belt. Cleaning the belt guide and seat belt should restore proper function of the seat belt retraction. To resolve, perform the following.

1. Clean the belt guide using MB Interior Care (Figures 1 and 2).
2. Clean the [seat belts](#) using MB Car Shampoo mixed with water, MB Textile Carpet/Fabric Care or clean, lukewarm water and soap. Do not treat the belt with any other cleaning agents.
3. Extend belt and allow to air dry. Do not dry at temperatures above 175 degrees F (80 degrees C) or in direct sunlight. Do not bleach or dye.

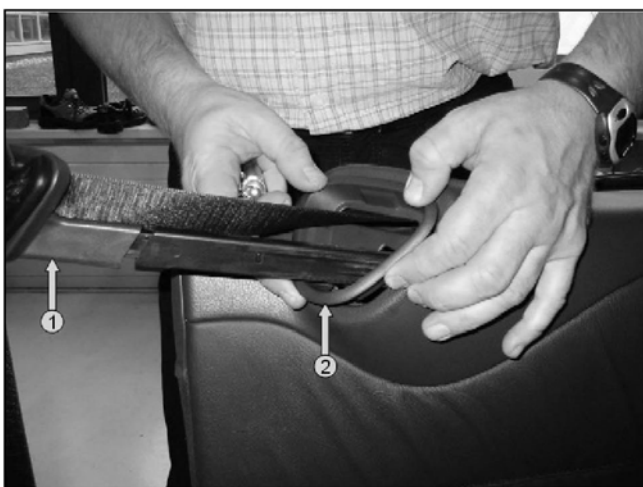
Figure 1

1. Carefully pull the seat belt extender (Figure 1, 1) out and unclip the cover frame (Figure 1, 2).

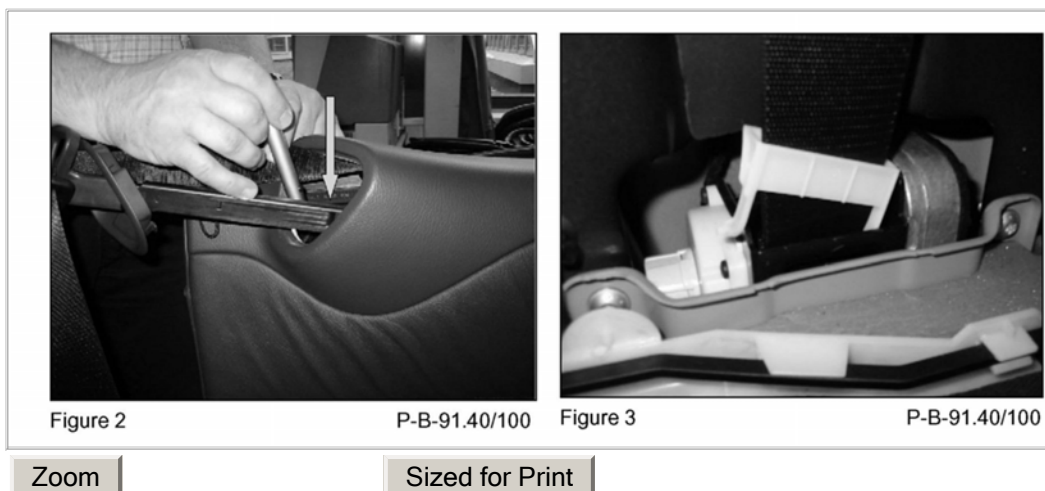
If you receive customer reports in the above model vehicle of the [seat belt](#) not retracting completely, perform the following procedure to secure the seat belt guide. The seat belt guide may have become detached from the inertia reel.

2. Pull the [seat belt](#) out completely and using a flashlight check to see if the seat belt guide has become detached (Figure 2 and 3).

2. Reinstall white plastic [seat belt](#) guide back into position.
