#05-08-67-014K: General Guide to Panoramic Sunroof Noise Issues (WPC P/N 401) - (Apr 7, 2008)

Models: 2005-2007 Pontiac G6
2007 Saturn Aura

This bulletin is being revised to update the Parts information. Please discard Corporate Bulletin Number 05-08-67-014J (Section 08 - Body and Accessories).

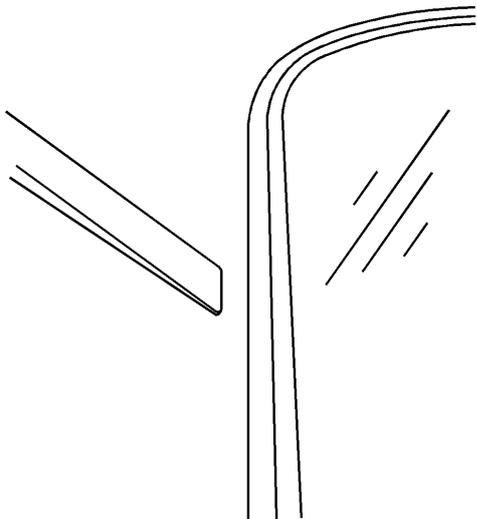
Pull seal out from under roof edge with trim stick.

Corrected position.

Repair rolled perimeter seal by spooning into position with "Trim Stick" or credit card type tool.

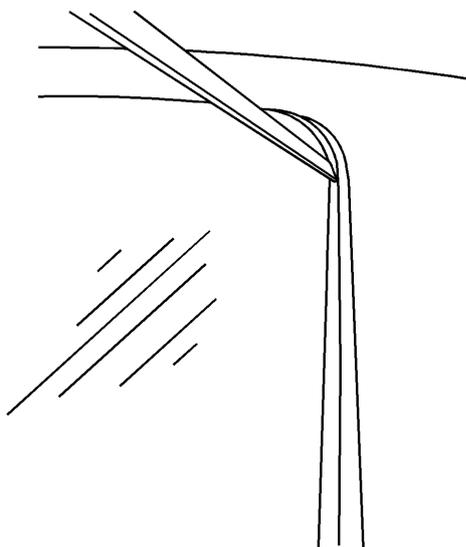
Push seal back under roof edge with trim stick.

Corrected position.
