TECHNICAL BULLETIN # 230A

TRANSMISSION: E4OD

SUBJECT:

No upshift 4th [gear](#) starts, harsh upshifts, neutrals out after shifts

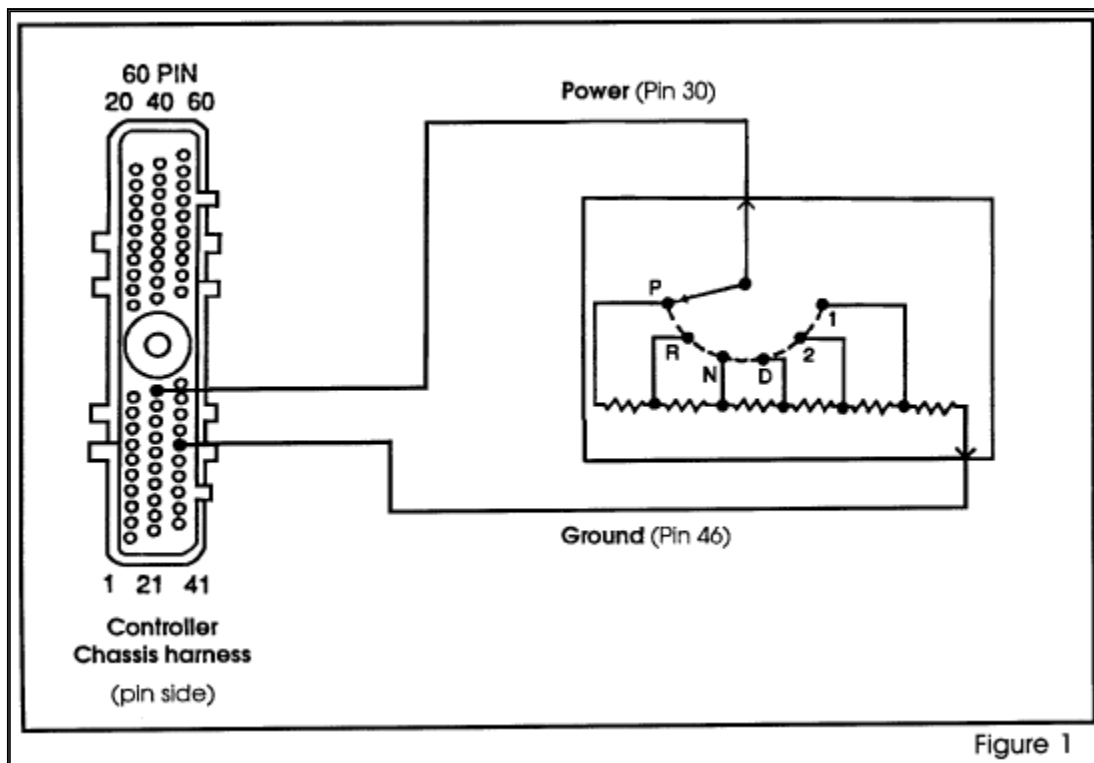
All of these concerns can be the result of an inappropriate Manual Lever Position (MLP) sensor signal. The MLP sensor consists of six resistors connected in series (ganged).

The resistance of the MLP sensor will vary based on which range the transmission is in. The MLP circuit can be checked using the following steps.
