HONDA ServiceNews

ASN 22447-40074 (0808)

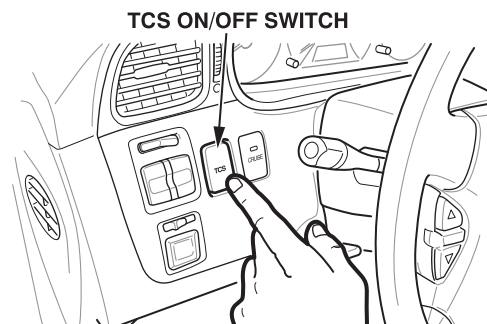
The TCS ON/OFF switch under the driver's side vent lets you turn the TCS off and on. When you press the switch, the TCS is *off* and the TCS indicator comes on as a reminder. When you press the switch again, the TCS is *on*, and the indicator goes off. You *cannot* turn off the TCS while the TCS indicator is blinking.
