SERVICE BULLETIN

EC09-029

2000-2005 SENTRA; MIL “ON” WITH DTC P1138

APPLIED VEHICLES: 2000-2005 Sentra (B15) – with QG18DE Engine **ONLY**

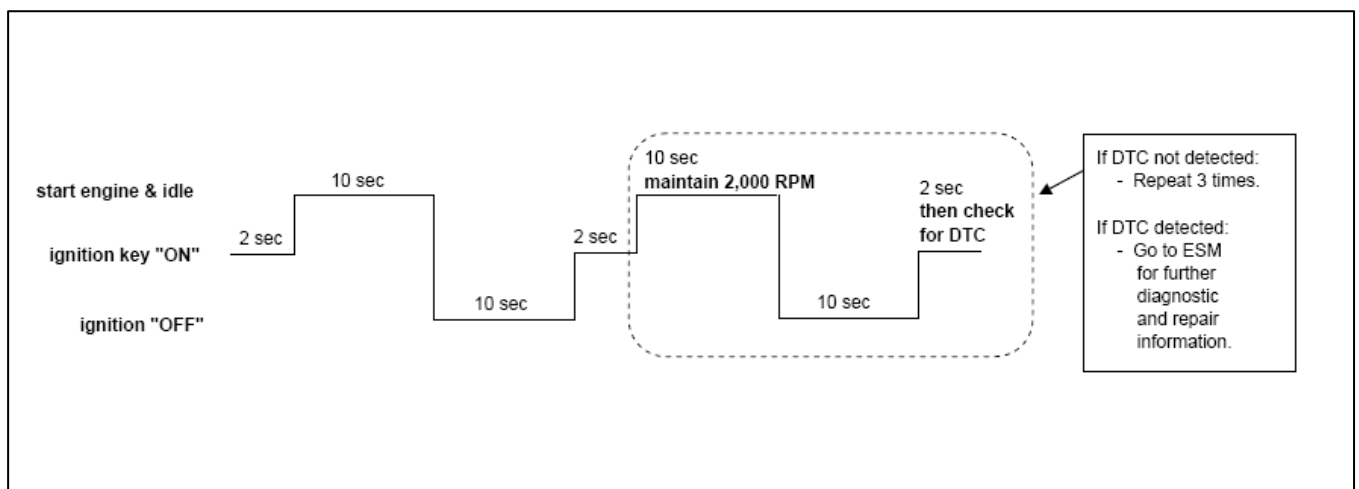
Figure D

1. Turn the ignition switch "ON" and wait at least 2 seconds. (See Figure D.)
2. Select “Data Monitor” mode with CONSULT-II.
3. Start the engine and let it idle for at least 10 seconds.
4. Turn the ignition switch "OFF" and wait at least 10 seconds.
5. Turn the ignition switch "ON" and wait at least 2 seconds.
6. Start the engine and let it idle for at least 10 seconds.
 - Maintain engine speed at about 2,000 rpm for at least 10 seconds.
7. Turn the ignition switch “OFF,” wait at least 10 seconds, then turn the ignition switch “ON.”
 - If DTC P1138 resets, refer to the appropriate ESM for further diagnostic and repair information.
 - If DTC P1138 is not detected, proceed to the next step.
8. Perform steps 5 through 7 three times.
