[Conversion Calculator](#)**2000 Mazda Protege LX L4-1.6L DOHC**[Vehicle Level](#) → [Technical Service Bulletins](#) → [All Technical Service Bulletins](#) → [Engine Controls - MIL ON/Driveability Concerns](#) ←**Engine Controls - MIL ON/Driveability Concerns**

Bulletin No: 01-018/01

MIL ILLUMINATION WITH P0171, P1170, LACK OF POWER, HESITATION

All 1999-2000 Protege 1.6L with VINs lower than JM1 BJ222* *0 300996.

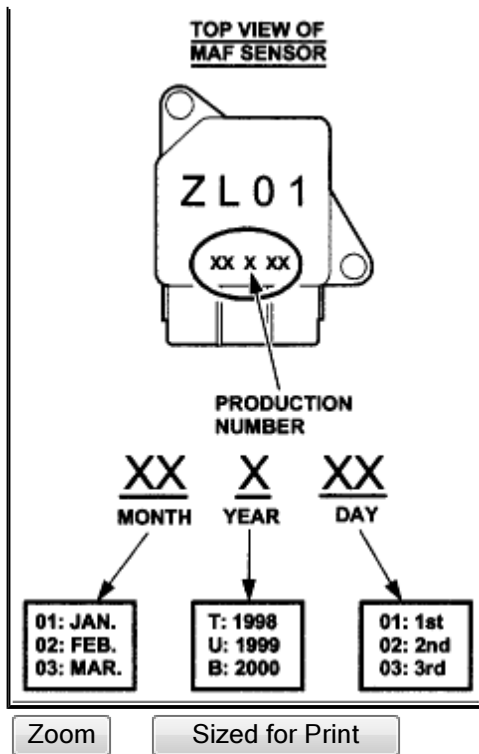
1. Verify customer concern.
2. Record DTC and Freeze Frame data.
3. Inspect intake system for vacuum leaks.
4. Identify production date on MAF sensor.

- If MAF sensor has a production date before 07B27 (July 27, 2000), proceed to STEP 5.
 - If MAF sensor has a production date on or after 07B27 (July 27, 2000), this Service Bulletin does not apply. Refer to Workshop Manual for further diagnostic procedures.
5. Clean surface surrounding MAF sensor.
 6. Replace MAF sensor.

Note: Make sure O-ring is correctly positioned on replacement MAF sensor before installation.

- ^ Do not allow water to enter MAF sensor connector.
 - ^ Handle replacement MAF sensor with care.
7. Inspect air cleaner and correct any unfiltered air leaks:
 - ^ Improperly positioned air cleaner element and/or deformed seal.
 - ^ Broken tabs, cracks and/or deformities of the air cleaner.
 8. Disconnect negative battery cable or pull INJ fuse to erase and reset KAM (Keep Alive Memory).
 9. Verify repair.
